# Mount Forest Drainage Study

AREA EAST OF MAIN STREET SOUTH (HWY 6) AND  
SOUTH OF SOUTH SAUGEEN RIVER

BMROSS PROJECT #25155

JUNE 22, 2026

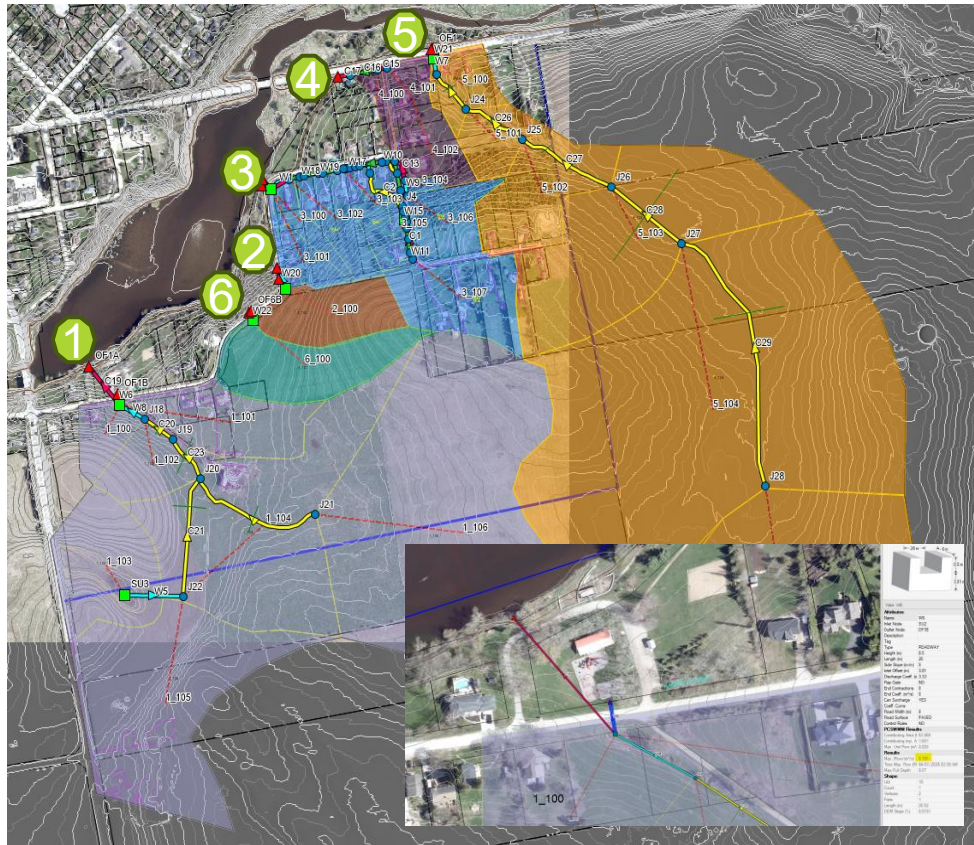
Catchment/Outlet #1 – Murphy St. @ Park - 64 Ha Drainage Area  
~750mm Dia. Culvert Outlet

- ▶ Murphy Street culvert undersized (cannot convey 25 yr storm without overtopping) ✖
- ▶ This culvert is in poor condition near outlet ✖

- ▶ Additional model refinement
- ▶ CCTV inspection of 750mm Culvert
- ▶ Culvert replacement – 900 or 1050mm dia.

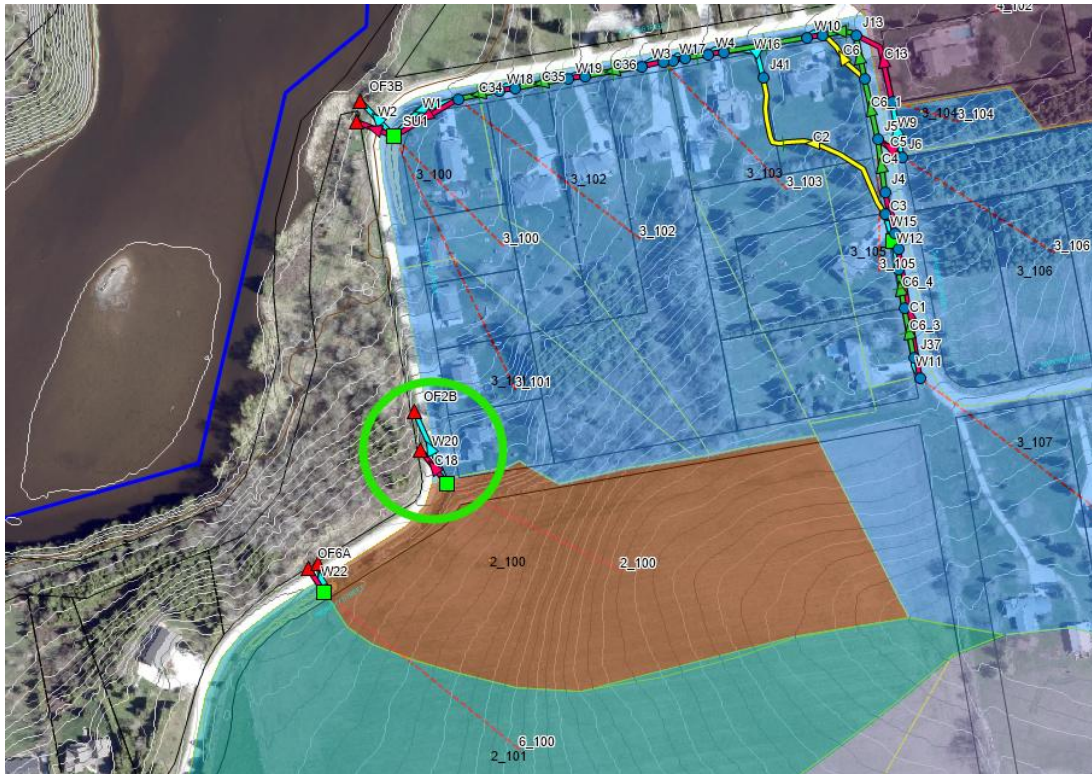
Catchment/Outlet #2 – @ Murphy/Glasgow Bend - 3 Ha Drainage Area  
450mm Dia. Culvert Outlet

- ▶ Culvert sufficiently sized ✓
- ▶ Erosion at outlet ✗
- ▶ No defined conveyance from culvert outlet to river, flows across trail ✗

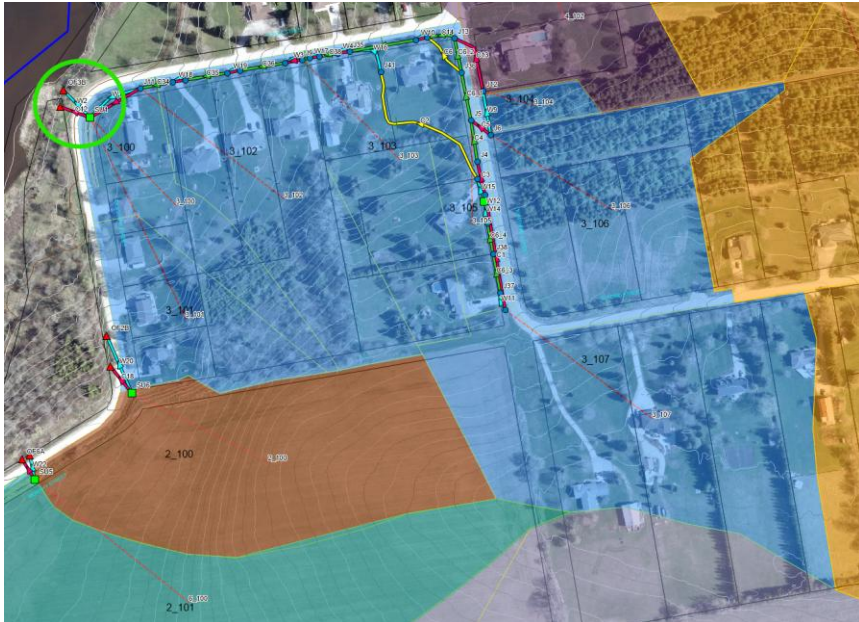
## Catchment/Outlet #3 – @ Glasgow/Clyde Bend - 12 Ha Drainage Area ~900mm Dia. Culvert Outlet

- ▶ 900mm culvert at Clyde/Glasgow bend and most driveway culverts in Clyde St south ditch are sufficiently sized ✓
- ▶ Two (2) driveway culverts in Clyde St south ditch are undersized ✗
- ▶ Flows along Ayrshire St west ditch spill onto private property at south side of driveway to #425 Ayrshire during 100 yr storm ✗
- ▶ Ayrshire St west ditch adjacent to #460 Clyde St sufficiently sized but sensitive to conveyance reductions - undesirable
- ▶ Spills from Clyde St south ditch across to Clyde St north ditch under several storm scenarios – undesirable
- ▶ Clyde St north ditching poorly defined, allowing spills onto private property ✗

- ▶ Infrastructure Improvement: Clyde Street Culvert/Ditching Upgrades
  - ▶ At minimum, consider upgrading undersized culverts in south ditch and improving ditching in north ditch
  - ▶ Larger project: uniformly increase south ditch driveway culvert capacity – either increase size or twin
  - ▶ Larger project would resolve deficiencies except for private property spills along Ayrshire Street west ditch
  - ▶ Combination project (culvert/ditching upgrades coupled with the diversion project) could resolve all deficiencies in this Catchment

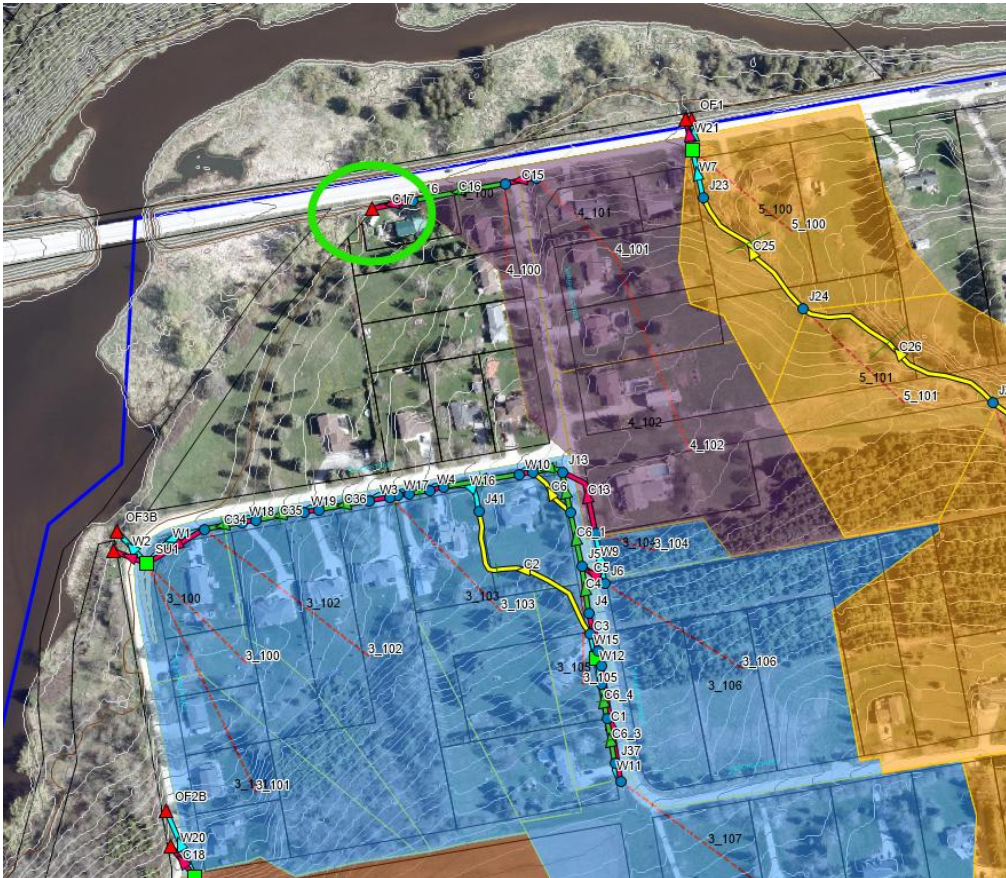
Catchment/Outlet #4 – @ Queen St. South Side - 3 Ha Drainage Area  
~600mm Dia. Culvert Outlet

- ▶ Culvert sizes sufficient to meet Township standards ✓
- ▶ Ditching along Ayrshire Street (Clyde to Queen) poorly defined and some culverts buried ✗

- ▶ Ditching improvements – minor excavation - along Ayrshire Street (Clyde to Queen) on both sides
- ▶ Replace existing driveway culverts

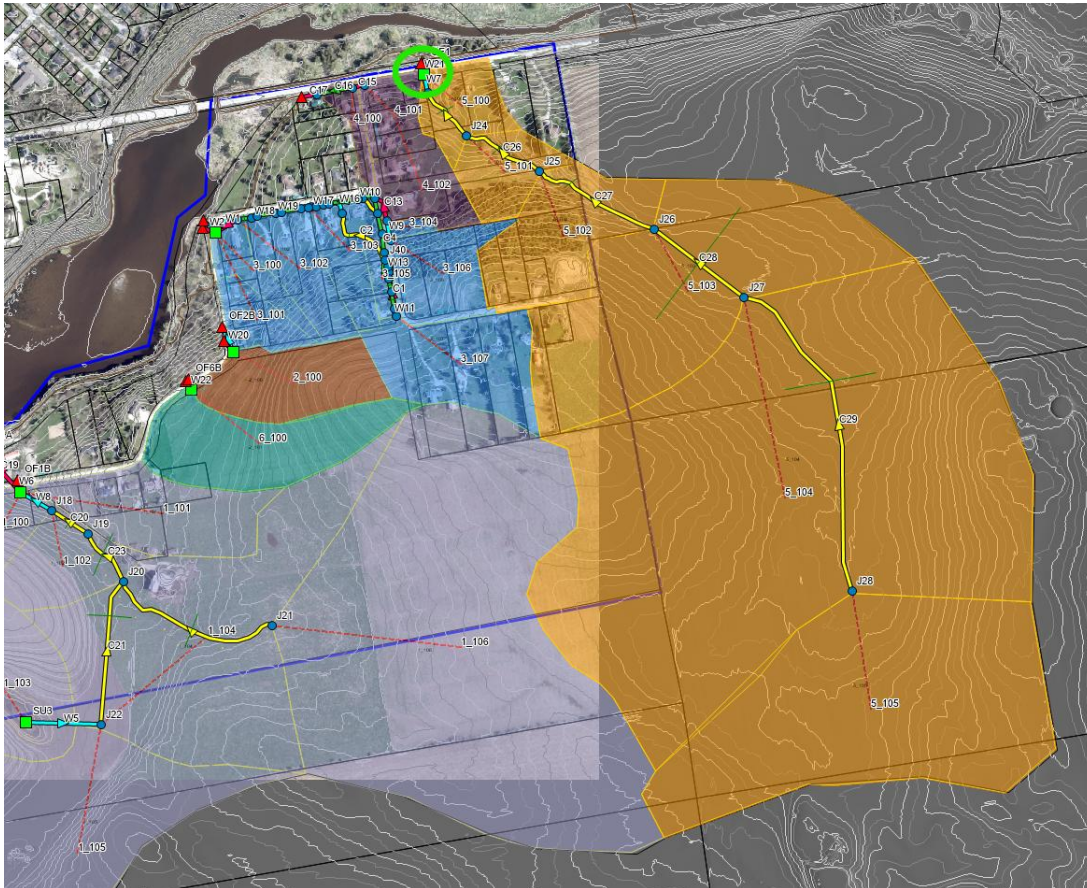
Catchment/Outlet #5 – @ Queen St. North Side - 73 Ha Drainage Area  
1200mm Dia. Culvert Outlet

- ▶ 1200mm culvert size sufficient to meet Township standards ✓
- ▶ Under 100 yr storm, overflow routed to west along South Ditch to Outlet #4 - undesirable
- ▶ Significant erosion at downstream end of culvert (culvert is within connecting link) ✗

- ▶ CCTV inspection of existing 1200mm culvert
- ▶ Further model refinement to confirm spill to west
- ▶ Repair erosion/scour at downstream end
- ▶ Candidate for provincial funding since in connecting link
