## TOWNSHIP OF WELLINGTON NORTH

REPORT #: INF 2026-008

REPORT TITLE: Mount Forest Southeast Drainage Study

## Memo

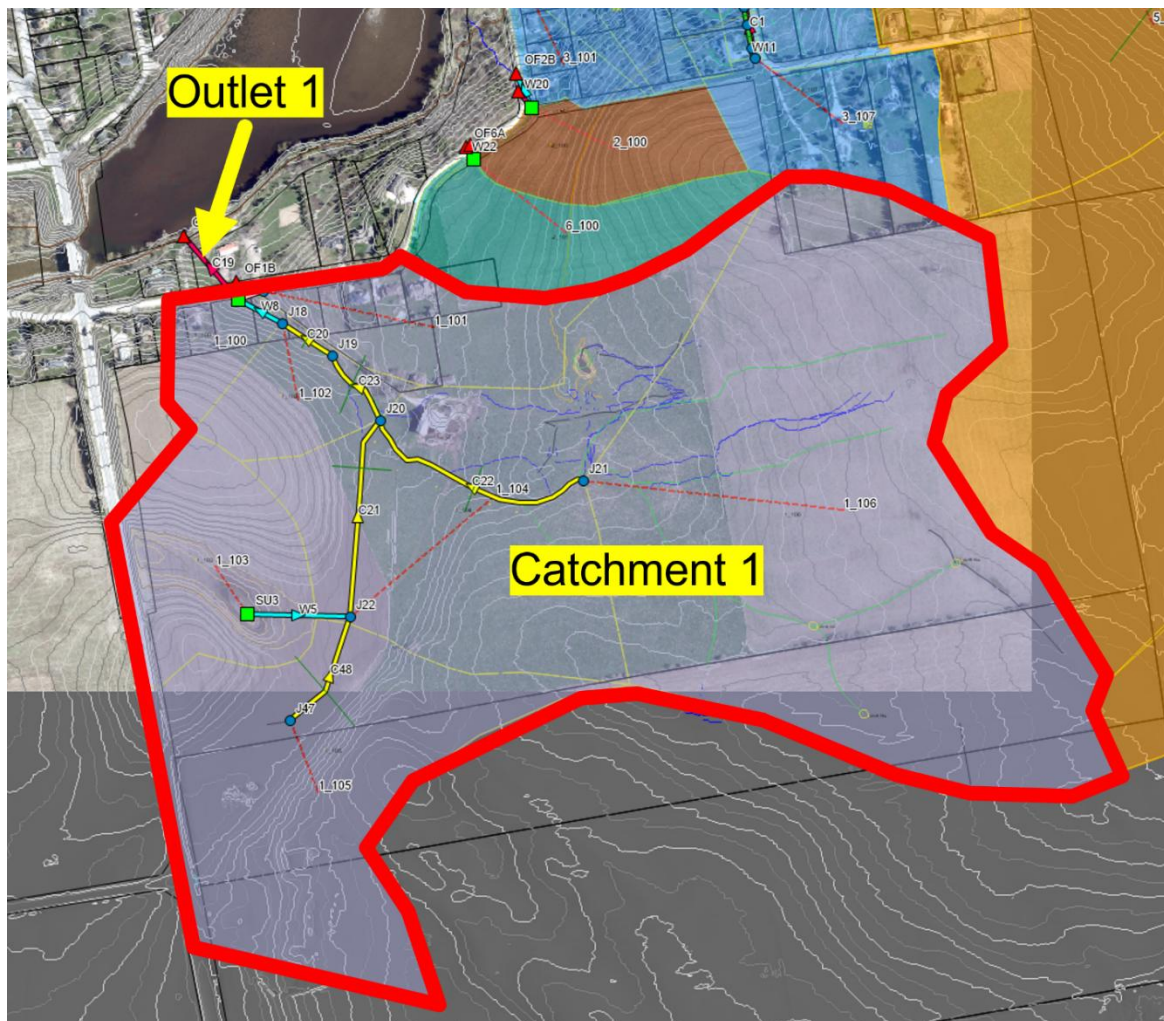
Figure 3 – Outlet/Catchment 1

In our opinion the predicted overtopping of the driveway to #180 Murphy Street should be considered a very minor deficiency, given the minor overtopping flow predicted and the conservative nature of the PCSWMM model. The issue of the overtopping of Murphy Street is much more significant, as the model predicts that this will occur under conditions only marginally greater than the 10-year storm event, and predicts a significant overtopping flow of 1.32 cms under the 25-year storm flow, whereas the Township standards require road crossing culverts to convey the 25-year storm flow without resulting in overtopping. The large size of Catchment #1 (64 Ha) and the steep topography combine to produce peak flows that result in this existing culvert being undersized.

We note that during our site visit the downstream end of this culvert was observed to be in poor condition with visible holes in the top of the pipe and likely significant root intrusion due to the presence of a large tree almost directly on top of the outlet. The existing culvert is approximately 100m in length and extends all the way from the south side of Murphy Street to the edge of the river. The diameter of the pipe measures 900mm at the inlet end and 750mm at the outlet end. From publicly available historical aerial photography (1954), it appears that what is currently buried culvert on the north side of Murphy Street formerly consisted of an open ditch. Therefore, it is possible that this culvert was much shorter in the past and was extended due to the development of the park. Figure 4 illustrates the location of the culvert in 1954.

- Overtopping of Murphy Street under 25-year storm, contrary to Township standard;
- Minor overtopping of driveway to #180 Murphy Street during 10 year storm; contrary to Township standard;
- Poor condition of existing outlet.

This would be useful to confirm whether the existing 100m long 750mm dia. culvert under Murphy Street and Murphy Park is in poor condition throughout its length or whether this is confined to the end.

3. **Culvert Replacement**

Depending on the results of items 1 and 2 above and Township priorities, the Township could consider a replacement of the existing 750mm culvert as a capital project. As the model stands currently (i.e. without further discretization), we predict that a 900mm or 1050mm culvert will be sufficient to prevent overtopping of Murphy Street. The replacement project would require the provision of new pipe and would likely require a structure for a change in alignment, and inlet/outlet headwalls. Figure 12 illustrates a possible replacement project. This work could be done under the Township's CLI ECA but would require approval from the Conservation Authority as it would involve work within the SVCA's regulated area. Any tree removals required would need to be completed outside of bird nesting period of April 1 to August 31. Any in-water work would need to be completed in accordance with applicable fisheries timing windows, and the Township would likely need to obtain a permit/letter of advice from the DFO. Finally, we note that the detailed design would need to account for the presence of site utilities, which were not assessed at this time.

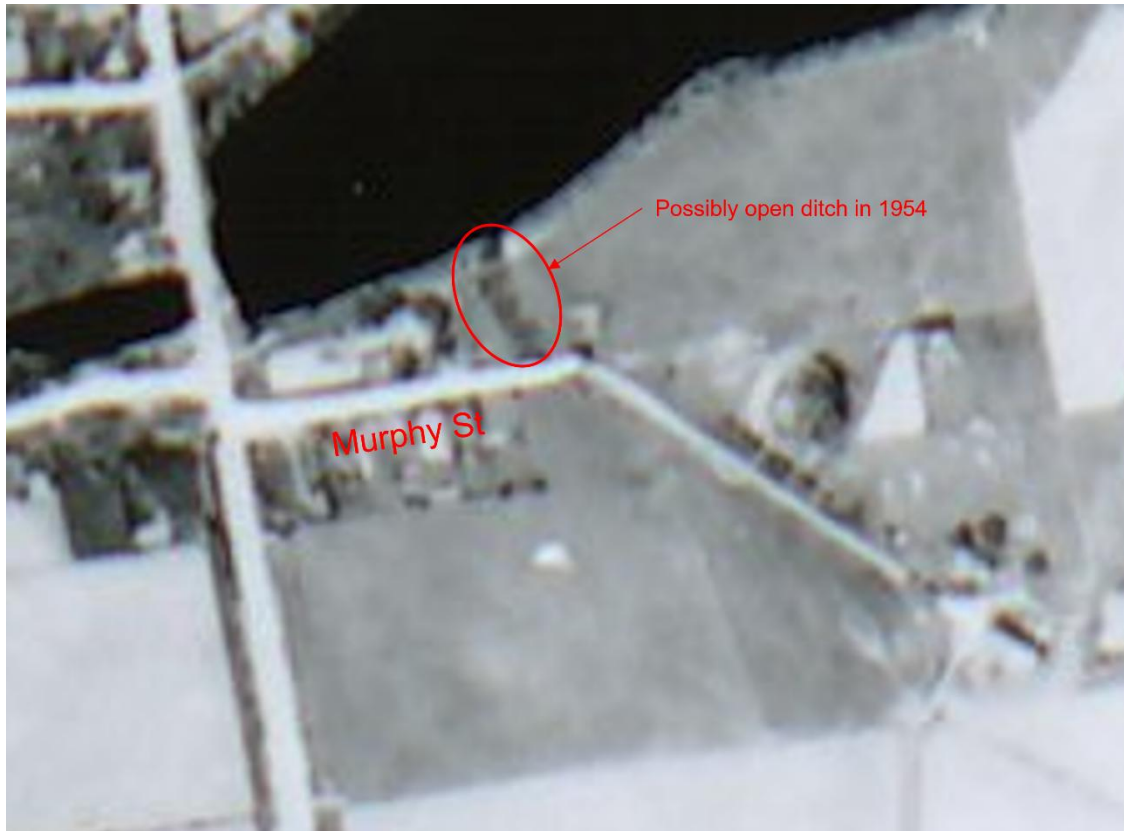
Figure 4 – Outlet 1 in 1954 (Background Imagery from University of Toronto Archive)

The extension of the culvert may have been completed by adding a 750mm diameter extension onto the downstream end of a formerly 900mm diameter culvert, which would explain the discrepancy between upstream and downstream diameters observed in the field. If the culvert was lengthened in the past this would have a negative impact on hydraulic performance, resulting in more upstream head required to “push” flows through. Regardless of the historical background, the modelling found the culvert to be undersized based on the evaluation criteria, and this should be addressed. A subsequent section will outline recommendations for the resolution of this deficiency.

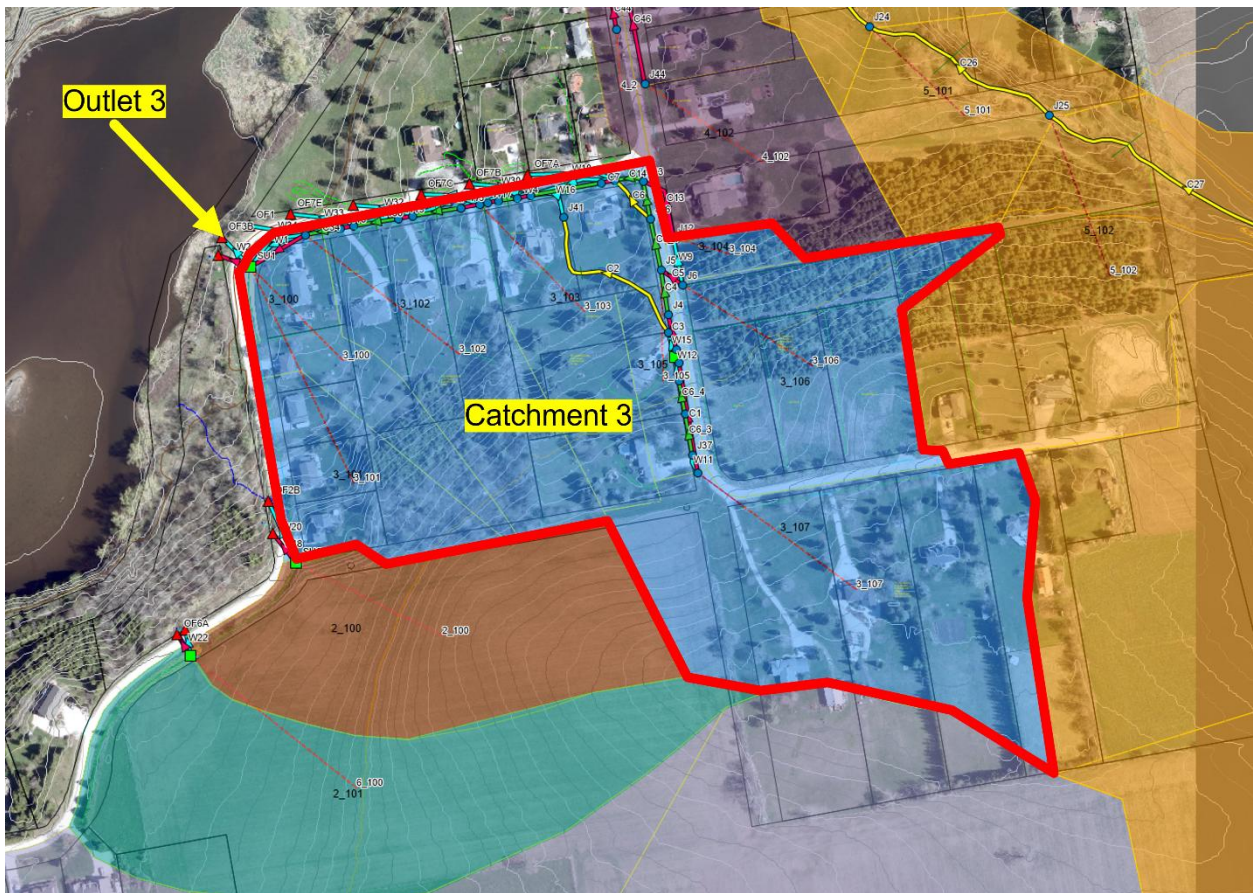
### Figure 6 – Outlet/Catchment 3

With this said, we note that our model results (which again did not account for recent work completed to build up the west side of the ditch) indicated relatively little additional capacity beyond that required to convey the 100-year storm. As a result, hydraulic performance at this location may be more sensitive to reductions in conveyance capacity resulting from ice accumulation, debris, vegetation growth, sediment deposition, unauthorized landscaping, or downstream restrictions than other conveyance elements within the system. For example, a blockage within the Clyde Street south ditch downstream of this location could result in backwater conditions that reduce the capacity of the Ayrshire Street west ditch and potentially cause flows to spill into the side yard of #460 Clyde Street during significant storm events. Similarly, snow and ice accumulation within this ditch section would reduce the available conveyance capacity and would increase the potential for localized overtopping. For context, the majority of runoff from approximately 6.3 Ha of land flows through this ditch section downstream of the road crossing culvert. Figure 7 illustrates the contributing drainage area (shaded in dark blue) represented in the PCSWMM model.

We discovered several deficiencies related to the ditching along Clyde Street. Firstly, we note that under the 10-year storm the model predicts minor overtopping of the east driveway to #450 Clyde Street (no other driveways along the Clyde Street south ditch are predicted to overtop during the 10-year storm). This deficiency is considered relatively minor. Secondly, we note that even during the 10-year storm, and increasingly under more significant rainfall events, the model predicts spill(s) across the road from the south ditch to the north ditch. This is predicted to first occur near the intersection with Ayrshire Street under the 10-year storm, and at other locations further to the west under more significant events. We note that the LIDAR topographic data indicates that near the Clyde/Ayrshire intersection, Clyde Street does not have a crowned cross-section and the road “tips” to the north, which encourages spills. Furthermore, our site visit noted that while the majority of the driveway culverts along the Clyde Street south ditch are 600mm diameter, one (#450 Clyde Street north driveway) appears to be 450mm diameter, and another (#460 Clyde Street) appears to be 525mm diameter. These smaller diameter culverts would have the impact of “throttling” the flow in the ditch as compared to the typical 600mm diameter driveway culverts located downstream. The effects of upsizing the driveway culverts and other possibilities for the modification to the Clyde Street south ditch system are discussed in a subsequent section.

Regarding flows that cross over Clyde Street from the south ditch to the north ditch, it is our opinion that this should be prevented from occurring under any of the design storm events, at least until or unless the north ditch is upgraded and specifically designed to convey these overflows. Therefore, we consider the existing conditions to be deficient. A detailed model of the north ditch system was not incorporated into the overall PCSWMM model. From site observations we also note that the existing north ditch is poorly defined and it is possible and even likely that flows which enter the north ditch (regardless of source) will spill onto the adjacent residential properties (#155, #415, #425 and #435 Clyde Street).

- Spill across #425 Ayrshire Street driveway onto private property (front yard of #417 Ayrshire Street and rear yard of #460 Clyde Street) during 100-year storm;
- Minor overtopping of #450 Clyde Street driveway under 10-year storm;
- Spills from Clyde Street south ditch across the road to the north ditch under various storm events;
- Two driveway culverts along the south ditch are undersized in comparison to the typical driveway culverts observed elsewhere along this ditch;

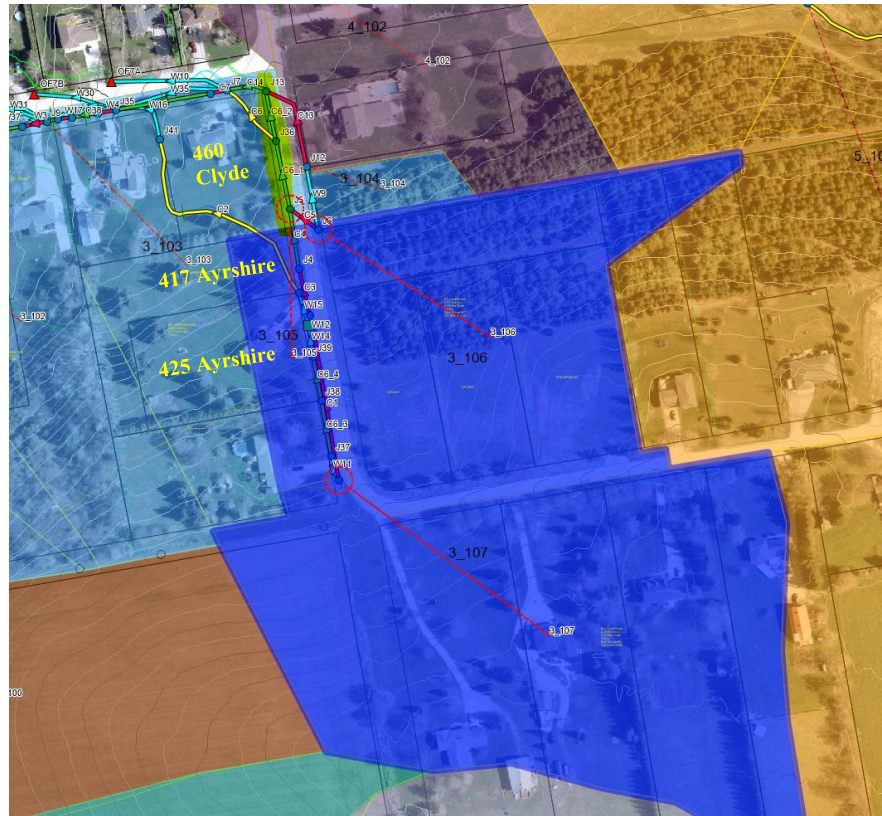
Figure 7 – Lands contributing to Ayrshire Street west ditch adjacent to #460 Clyde Street lot

We also note that, although we do not consider the west ditch on Ayrshire Street adjacent to #460 Clyde Street to be deficient, it may be more sensitive to reductions in capacity than other conveyance elements within the catchment. BMROSS notes the following possible solutions and next steps to address the identified deficiencies and/or reduce reliance on the ditch adjacent to #460 Clyde Street. Unless explicitly noted, each alternative was considered independent of all others.

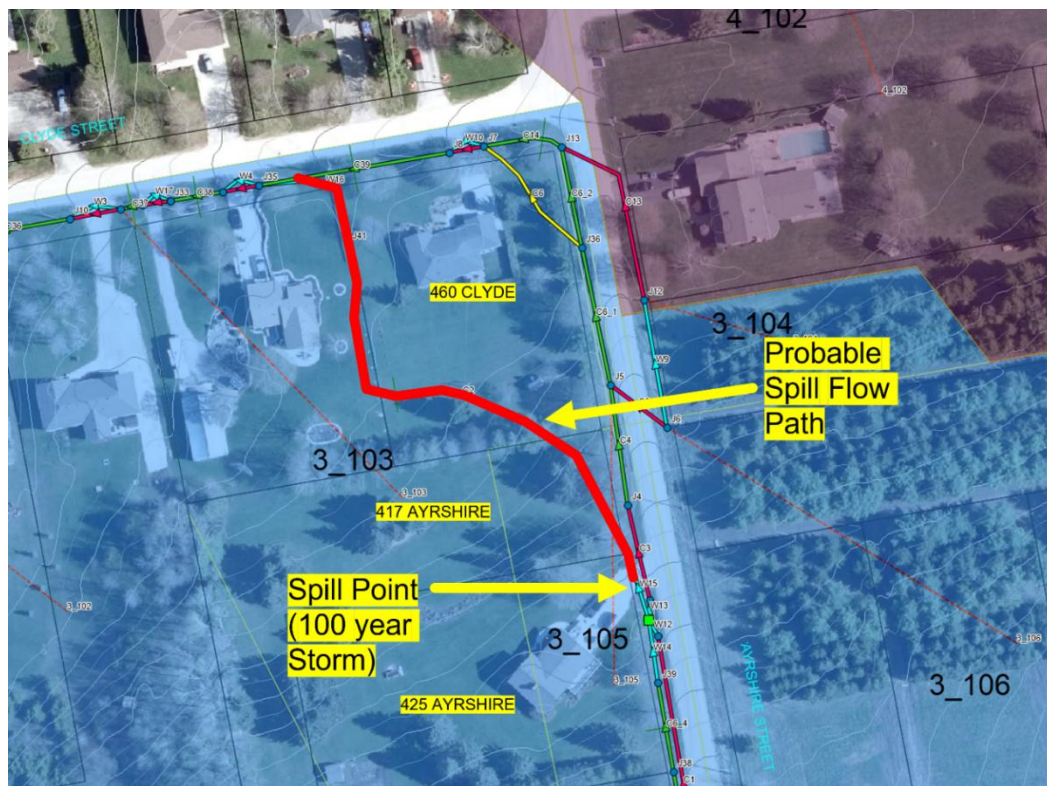
Figure 8 – Spill route (100-year storm) through private property (Note: House at #417 built after date of aerial imagery)

Based on our interpretation of the LIDAR topographic data and field observations, the model does predict a spill onto private property under the 100-year storm at the driveway to #425 Ayrshire Street. At this location, during a 100-year storm, the west ditch flow would build up on the upstream side of the driveway and would then spill over the driveway, across the front yard of #417 Ayrshire Street and into the rear yard of #460 Clyde Street. From there it would likely meander through the rear yard to an existing side yard swale and out to the Clyde Street south ditch. Figure 8 illustrates the inferred flow route.

As noted, this inferred overland drainage path is based on our interpretation of the LIDAR topographic data and supported by field observations but should be understood to be highly sensitive to the presence of snow/ice blockages, private landscaping features, and variations inherently present in the topographic data. Therefore, it is possible for these spills to follow an alternate path under the right conditions which could result in negative impacts to the property of #417 Ayrshire Street or #460 Clyde Street. As a result, this existing condition is considered deficient and should be resolved. Possible solutions are discussed in a subsequent section.

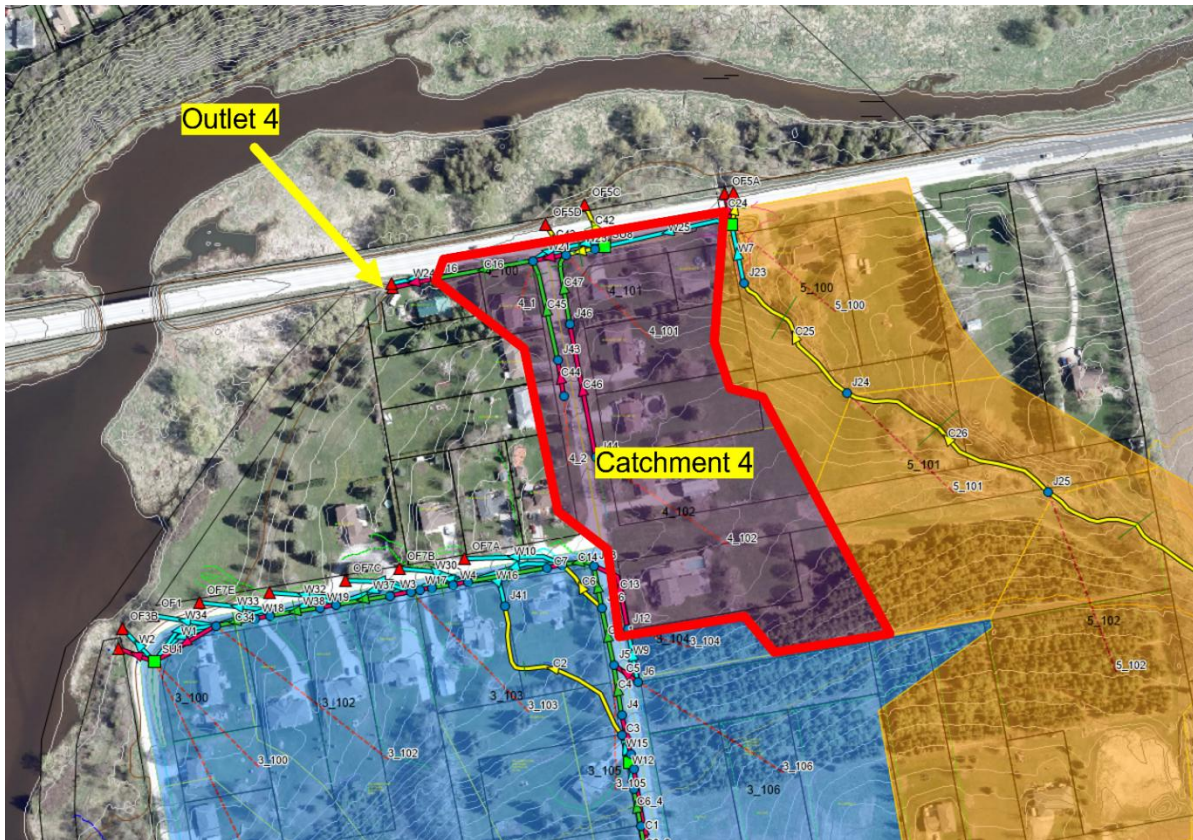
Figure 9 – Outlet/Catchment 4

The modelling indicated no obvious deficiencies in the drainage features for Catchment 4. Our site visit however did indicate that the ditches along Ayrshire Street between Clyde Street and Queen Street East are poorly defined, and that some of the driveway culverts are partially or fully buried (the model assumed functional culverts).

As outlined in Section 5.4, the modelling of existing conditions for Outlet/Catchment 4 did not identify any obvious deficiencies; however, our site visit did indicate that the ditches along Ayrshire Street between Clyde Street and Queen Street East are poorly defined, and that some of the driveway culverts are partially or fully buried. As such, we recommend the following work be completed by the Township:

- Excavation along both sides of Ayrshire Street (Clyde to Queen) to restore ditch functionality; and,
- Replacement of existing driveway culverts.

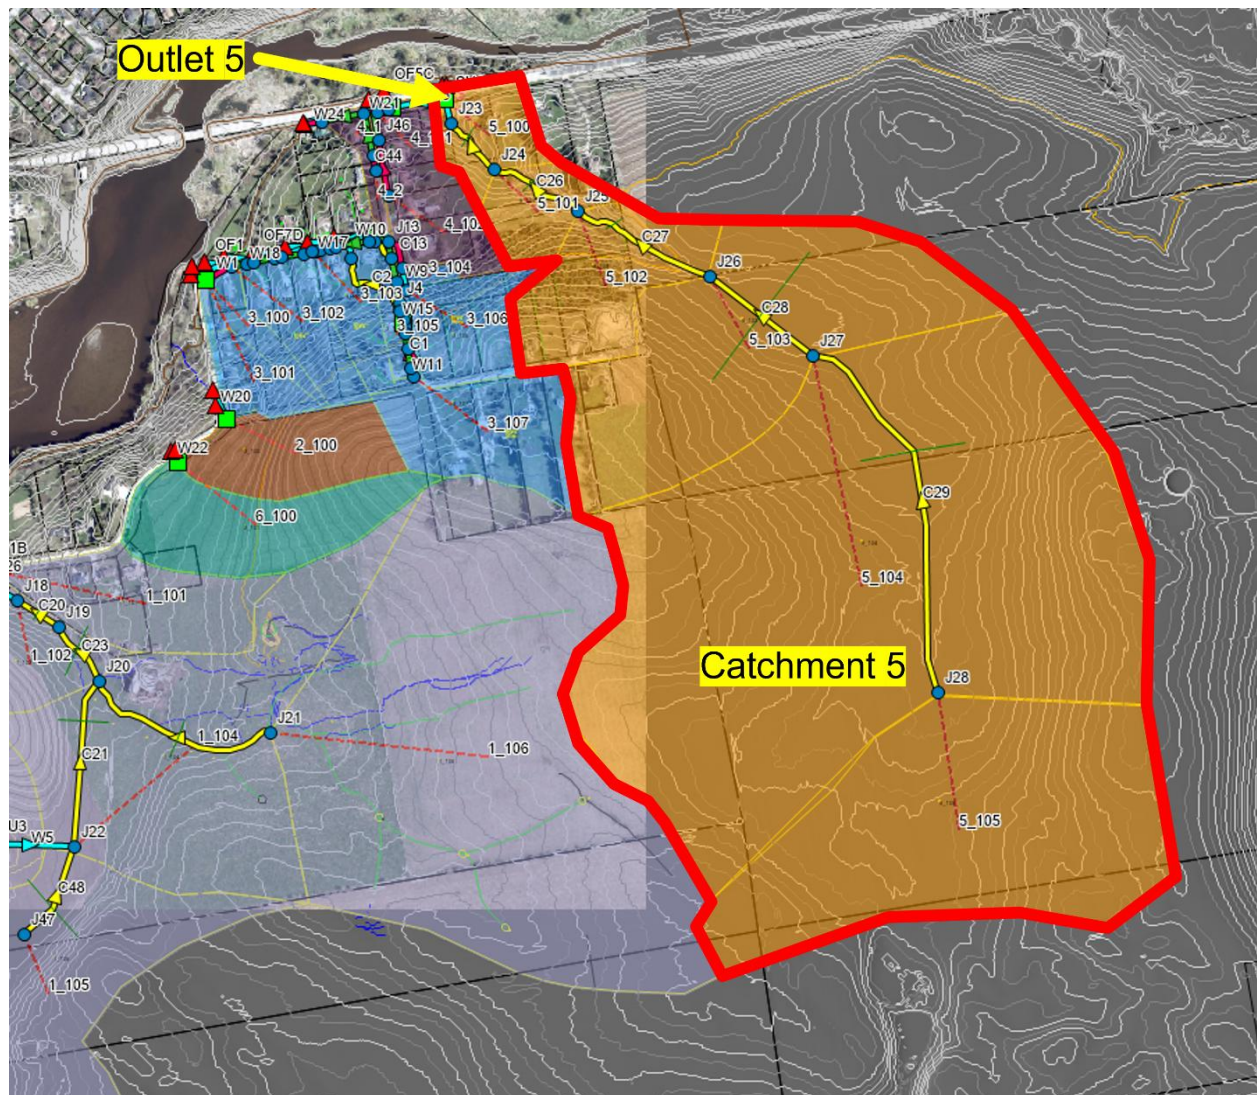
As noted earlier, Catchment 5 is very large (73 Ha) and consists of mostly fields or pasturelands. From the aerial imagery it appears that a gully develops approximately 100m upstream of the culvert and there is evidence of significant erosion from there to the culvert inlet. We note that almost no portion of the catchment or corresponding watercourse lies within Township property. At the downstream end of the culvert we observed significant scour such that the culvert outlet is exposed and protrudes beyond the embankment face, with discharge freely falling into a scour pool below.

Under significant (100-year storm) conditions, there will be significant ponding at the upstream end of the culvert. Beyond the discharge from the culvert itself, additional relief is provided by the overtopping of Queen Street and also the discharge of some water to the west along the Queen Street ditch towards Outlet 4. Although this overflow to the west does not necessarily contravene any Township standard, we believe it is nonetheless undesirable for this to occur. The model predicts that during the 100-year storm the maximum level of ponding at the upstream end of the culvert will not adversely impact the adjacent structures at 710 and 736 Queen Street East.

As outlined in Section 5.5, the modelling of existing conditions for Outlet/Catchment 5 did not identify any obvious deficiencies which contradicted Township standards, although it could be considered undesirable that under the 100-year storm some of the water which ponds at the upstream end of the 1200mm diameter road crossing culvert will overflow and spill to the west, ultimately discharging to the river flats via the Queen Street south ditch and Outlet 4. We also noted significant erosion at the downstream end of the existing 1200mm diameter culvert. We therefore recommend the Township complete the following work, at minimum:

- Complete a detailed condition assessment of this culvert including CCTV inspection; and,
- Repair erosion/scour at the downstream end.

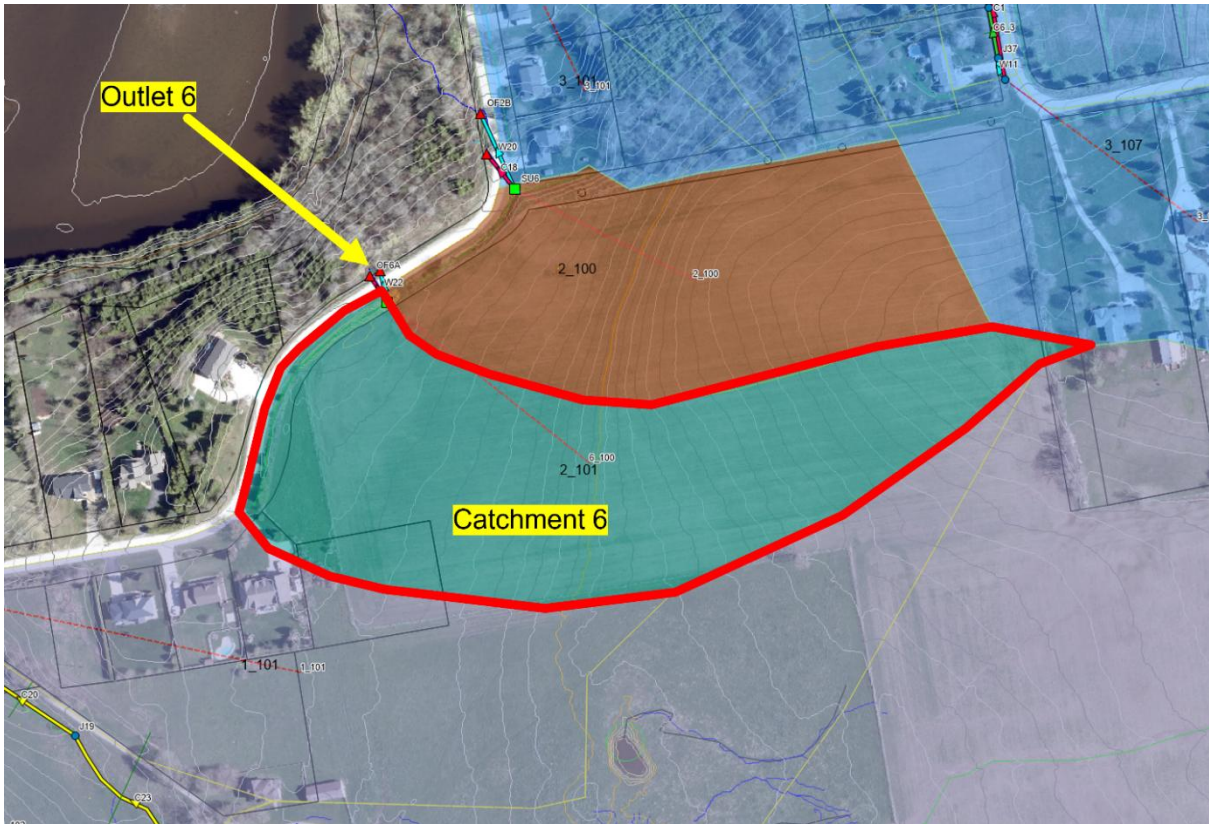
**Figure 11 – Outlet/Catchment 6**

The model results indicate that Murphy Street will not overtop during the 25-year storm at the location of the outlet, and therefore the Township standard is met at that location. While on site it was observed that the upstream end of the culvert is partly crushed which would have the effect of restricting capacity; therefore, the model results may not be indicative of actual performance at this location.

Furthermore, based on our late May 2026 observations, we note that between the downstream end of Outlet 6 and the river, the runoff crosses the South Wetlands Trail and that there is significant erosion at this crossing such that the culvert is exposed, and the trail requires maintenance to restore accessibility to pedestrians.

As outlined in Section 5.6, the modelling of existing conditions for Outlet/Catchment 6 did not identify any obvious deficiencies which contradicted Township standards. During a site visit, we observed that the upstream end of the 450mm culvert at Outlet 6 is crushed, and we also observed significant erosion at the culvert crossing at the South Wetlands Trail. To address deficiencies observed in the field, BMROSS recommends a replacement of the 450mm diameter road crossing under Murphy Street, and a replacement/restoration of the culvert crossing under the South Wetlands Trail. The Township could also consider constructing a defined open channel between the downstream end of the road crossing culvert and the river. Approval requirements for this project would be similar to those of the project outlined for Outlet 2.

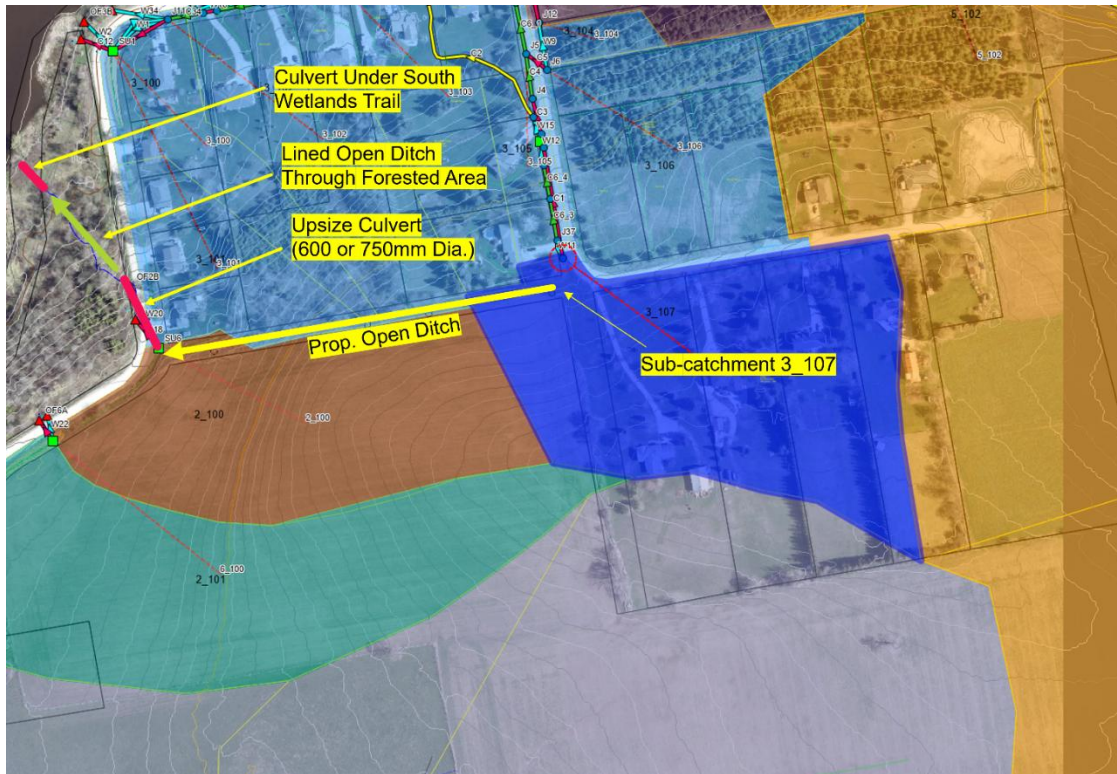
**Figure 13 – Diversion of Sub-Catchment 3\_107**

As noted previously, the Ayrshire Street west ditch adjacent to #460 Clyde Street is solely responsible for conveying a significant quantity of runoff. Figure 7 provided earlier illustrates the land which currently contributes runoff to this ditch – 6.3 Ha. To reduce reliance on this ditch, a portion of these contributing lands could be diverted westward towards Outlet 2. Figure 13 below illustrates this concept, where sub-catchment 3\_107 (3.7 Ha) is diverted to the west through the unopened Oxford Street right-of-way (ROW) to Outlet 2.

This would in effect reduce the drainage area which contributes to the above-noted ditch by about 50%. This would likely be a capital project and would require the following work:

While completing our site investigation we were able to survey the existing tree line along the unopened Oxford Street ROW as well as the survey bars where the ROW intersects with Ayrshire Street. A review of this data indicates that there is 10-11m of space between the south edge of the ROW and the tree line, which should be sufficient to construct a drainage ditch with dimensions noted above without requiring any tree removals.
