# Mount Forest Drainage Study

AREA EAST OF MAIN STREET SOUTH (HWY 6) AND  
SOUTH OF SOUTH SAUGEEN RIVER

BMROSS PROJECT #25155

JUNE 22, 2026

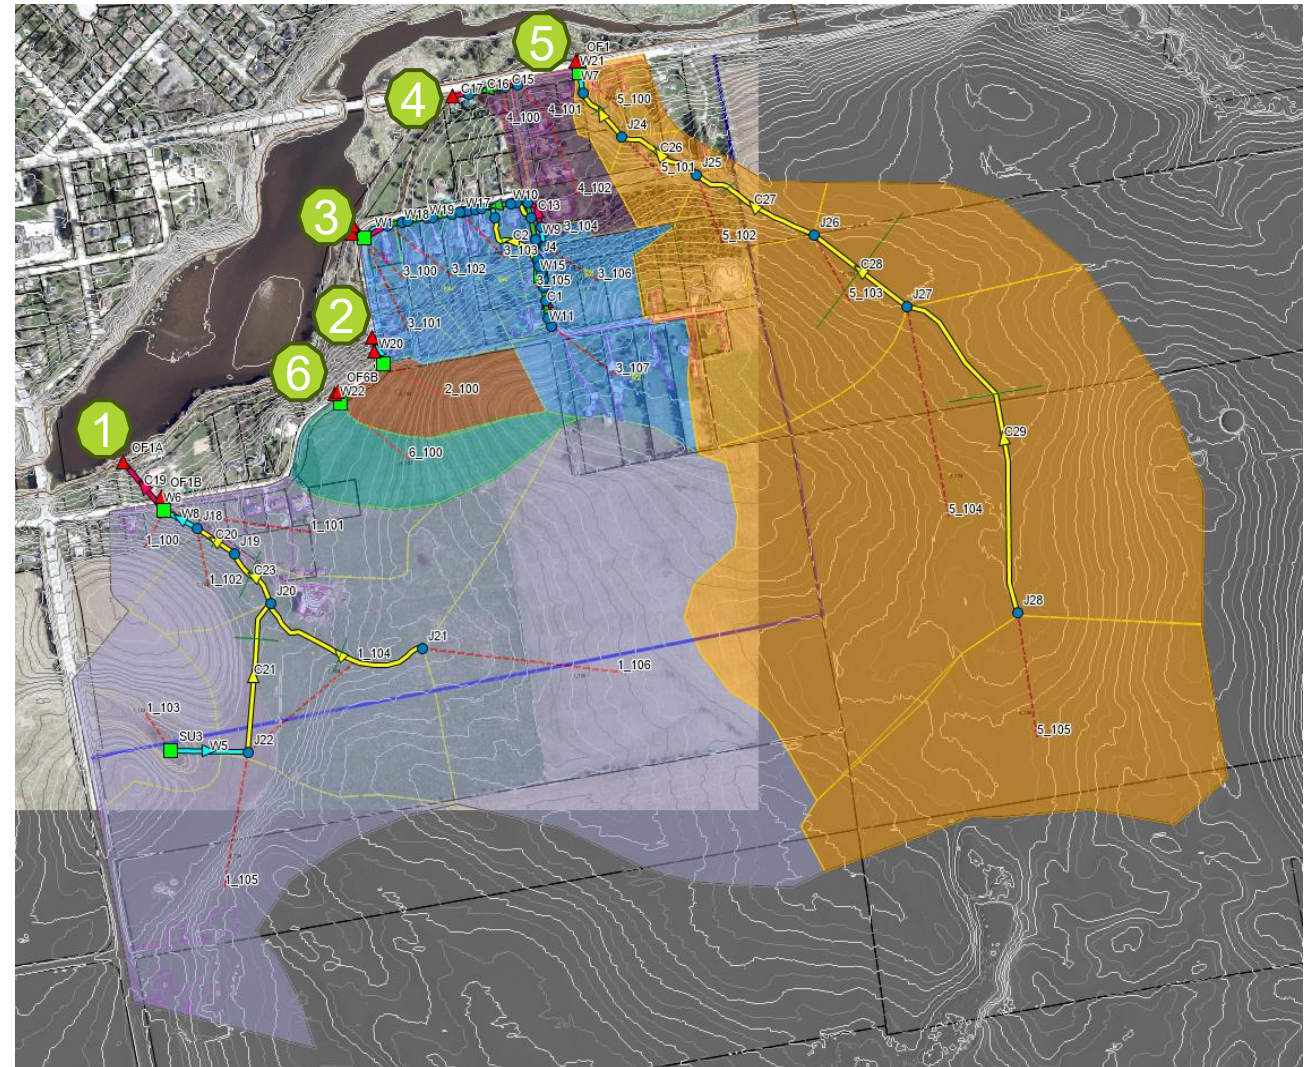
## Ex. Conditions Model Drainage Divisions

The overall drainage area was broken into 6 distinct catchments with 6 distinct outlets:

1. Murphy Street – at park (64 Ha)  
750mm Culvert Outlet
2. Murphy/Glasgow bend (3 Ha)  
450mm Culvert Outlet
3. Glasgow/Clyde bend (12 Ha)  
900mm Culvert Outlet
4. Queen St – south side (3 Ha)  
600mm Culvert Outlet
5. Queen St – north side (73 Ha)  
1200mm Culvert Outlet
6. Murphy St – 80m w. of Glasgow (4 Ha)  
450mm Culvert Outlet
