2021 ASSET MANAGEMENT PLAN

Transportation, Stormwater, Water and Wastewater Services

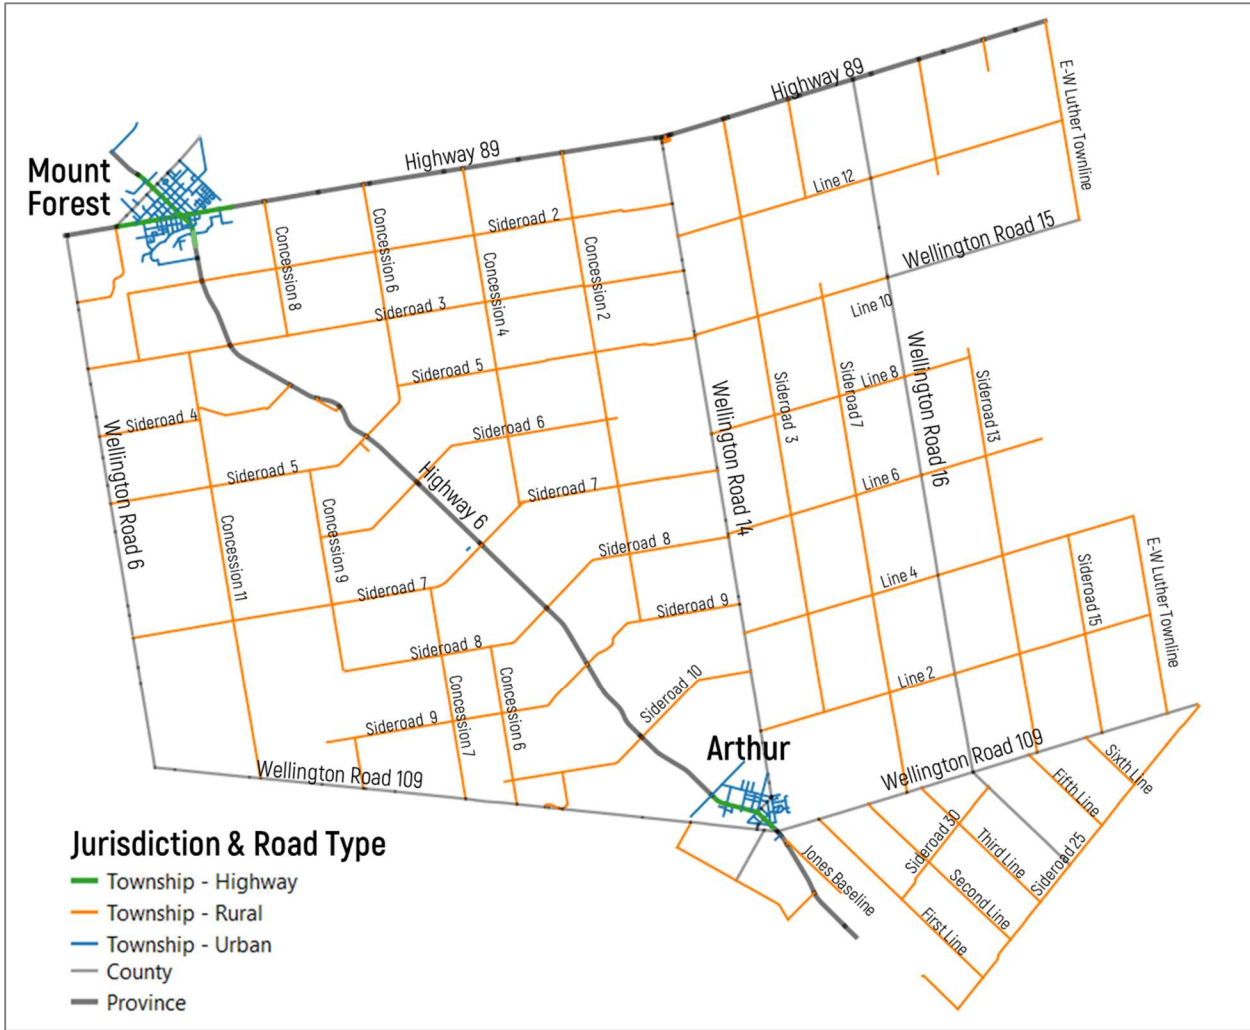
Figure 4-1: Map of Road Network

Table 4-1 shows that roads are the most significant asset type in the transportation asset portfolio, making up 73.6% of the value of transportation assets. Figure 4-1 shows a map of the roads managed by the Township, including local highways (green), rural (orange) and urban roads (blue). Roads shown in grey represent roads managed by the County and the Province and are included in the map for geographical reference.

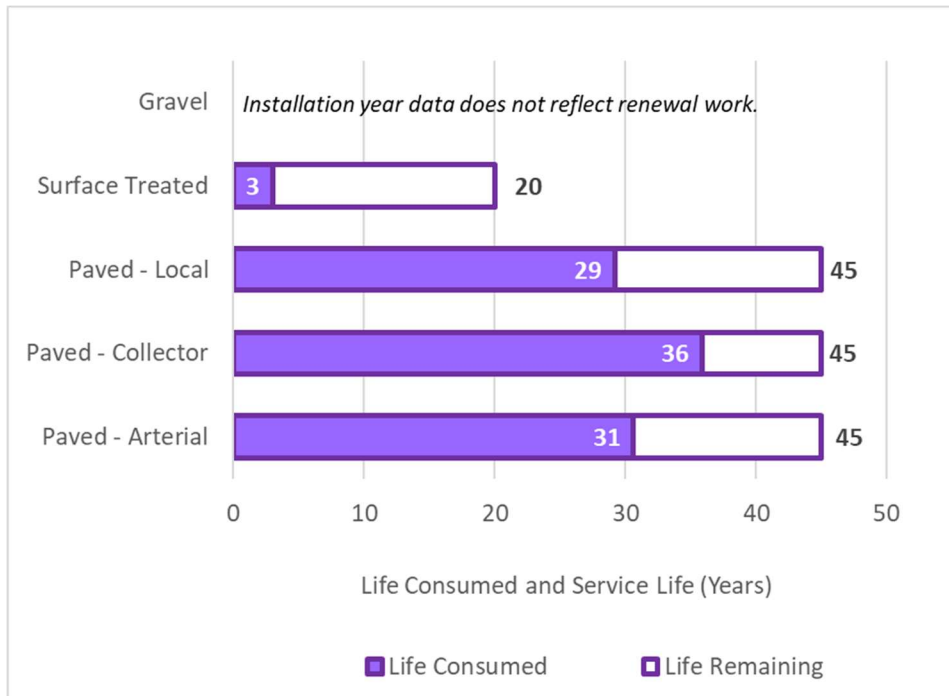
Figure 4-4: Average Age – Roads by Surface Type

Figure 4-4 shows the average age of roads by surface type. Figure 4-5 shows the bridge & culvert condition distribution by replacement value. As shown in the figure, some bridges and culverts are in Very Poor condition. Those are listed in Table 4-7.

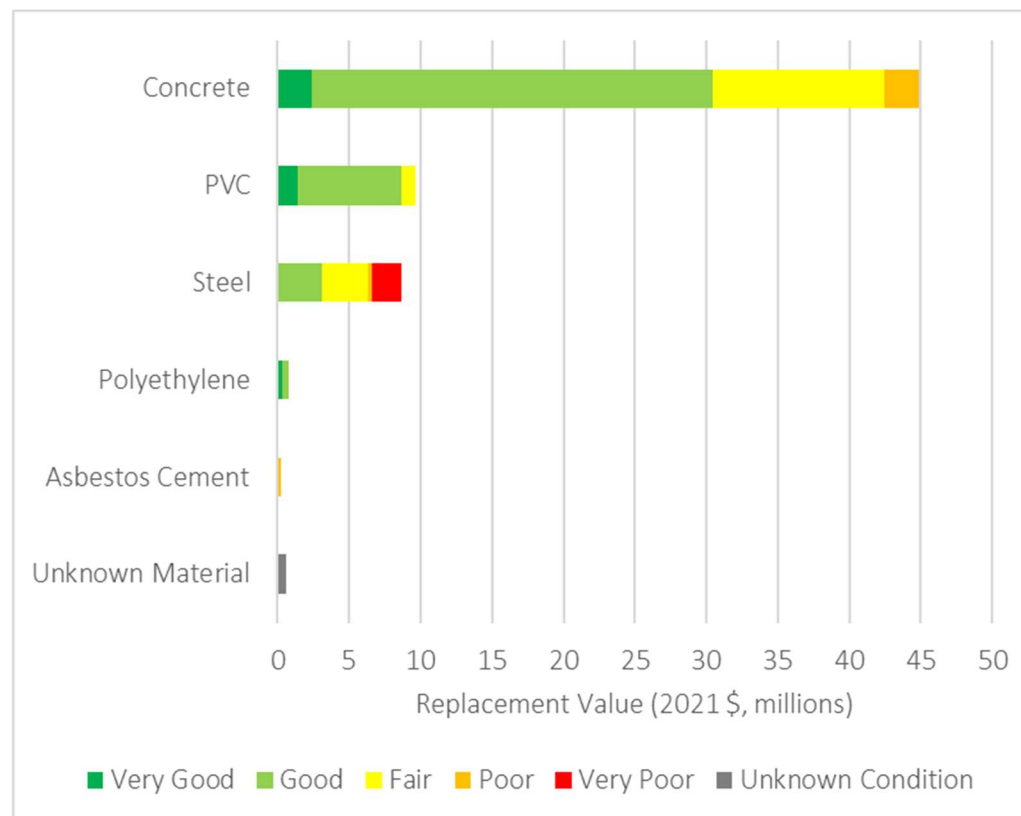
Figure 4-16: Stormwater Pipes – Condition by Replacement Value

The condition distribution of stormwater mains is shown in Figure 4-16. The figure shows that 1.2 km of steel mains are in Very Poor condition based on age and are thus due for replacement. Specifically, 2.7 km of asbestos cement mains and 148m of steel mains are in Very Poor condition. Another 2.0 km of mains (concrete, steel and asbestos cement) are in Poor condition.

Figure 4-17 shows the average age of stormwater pipes by material. The Figure shows that Asbestos Cement (AC) pipes are farthest along in their life; however, as was shown in Figure 4-16, there is only a small amount of AC pipe in the stormwater network (33m). The remaining types of pipe are about one third through their life cycle, other than steel pipes, which are on average, just over halfway through their life cycle.

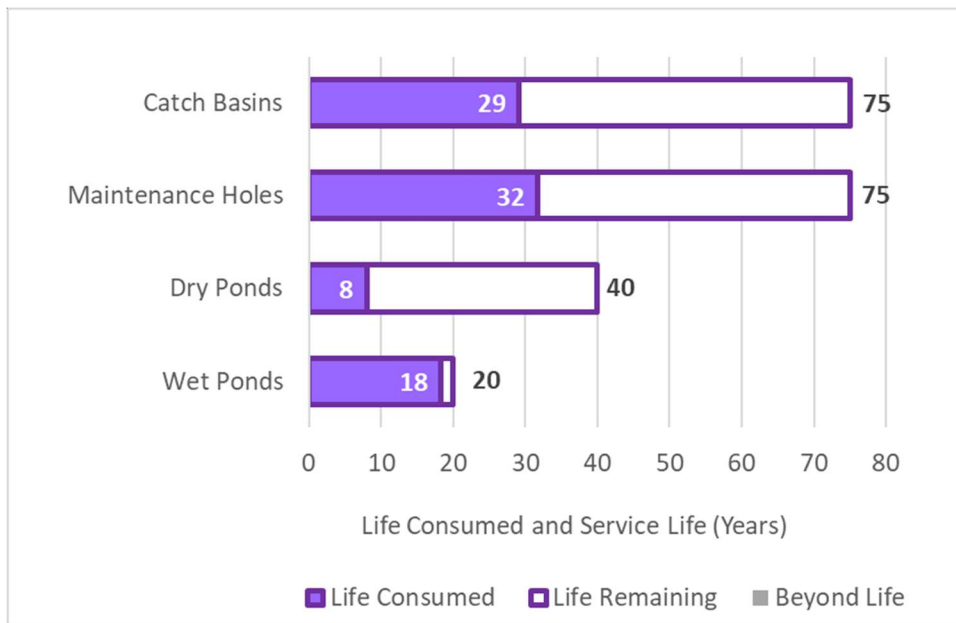
Figure 4-19: Average Age – Stormwater Appurtenances and Ponds

Figure 4-19 shows the average age of the stormwater appurtenances and ponds. The figure shows that wet ponds are on average, two years away from their Estimated Useful Life (EUL). They will require cleaning to re-capture capacity.

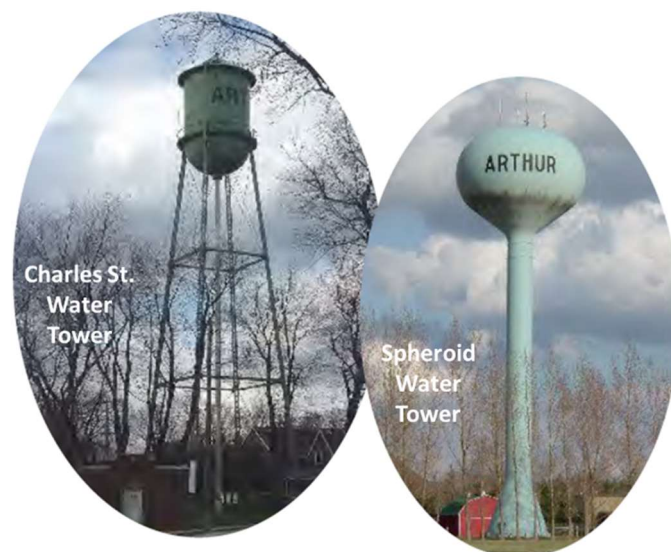
In the category of Water Towers in the Arthur water system, the Charles St. Tower, which was built in 1932, is nearing its 100-year estimated useful life, and is showing as \$1.1 million of assets in Very Poor condition. The Spheroid Water Tower was built in 1967, and is considered in Fair condition, with an estimated replacement value of \$3.6 million. Photos of the two towers are shown in Figure 4-31.

Figure 4-31: Water Towers serving the Arthur Community

In June 2021, the Township approved a decision to replace both towers with a single new tower at the north end of Arthur. The estimated cost of the new tower is \$3.7 million, excluding costs of potential need for watermain extension and looping. The new tower will increase the current water storage capacity of 1,364 m³ to 2,000 m³ and will thus accommodate planned development to the year 2045.
