**MOUNT FOREST
SANITARY AND WATER SERVICING**

TECHNICAL UPDATE

January 6, 2021

File No. 20013

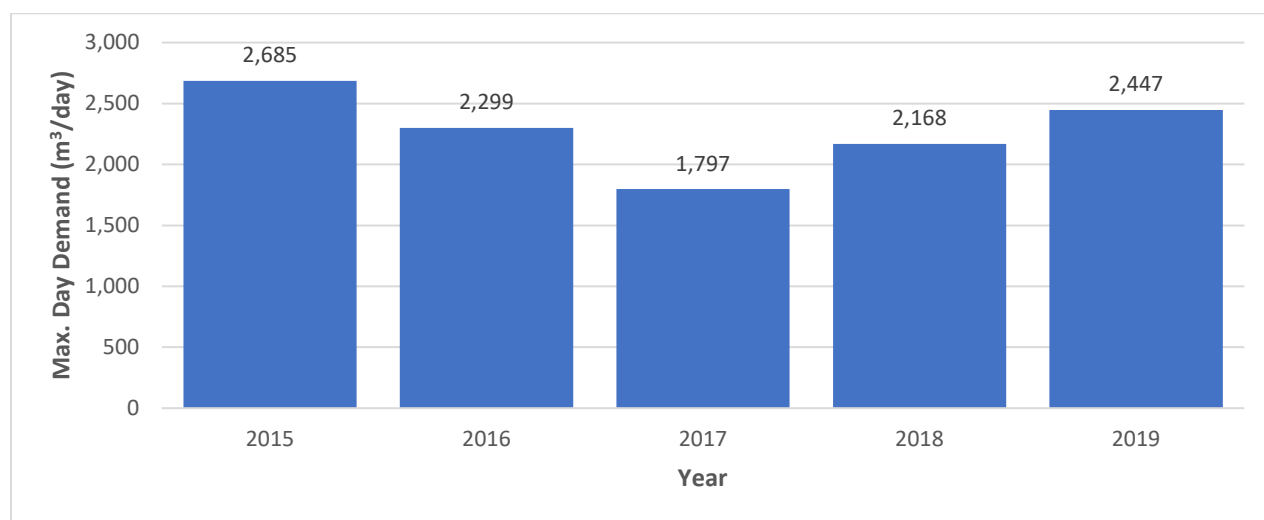
Figure 4.1
Maximum Day Demand (2015-2019)

Therefore, the maximum day demand during the past five years was 2,685 m³/day. Based on the 1,407m³/day average annual water use during this period, the maximum day factor is calculated to be 1.9. For the current population of Mount Forest, MECP Guidelines recommend using a maximum day demand factor of 2.0, and this is what has been used in this study for the water supply, water storage and water distribution design calculations.

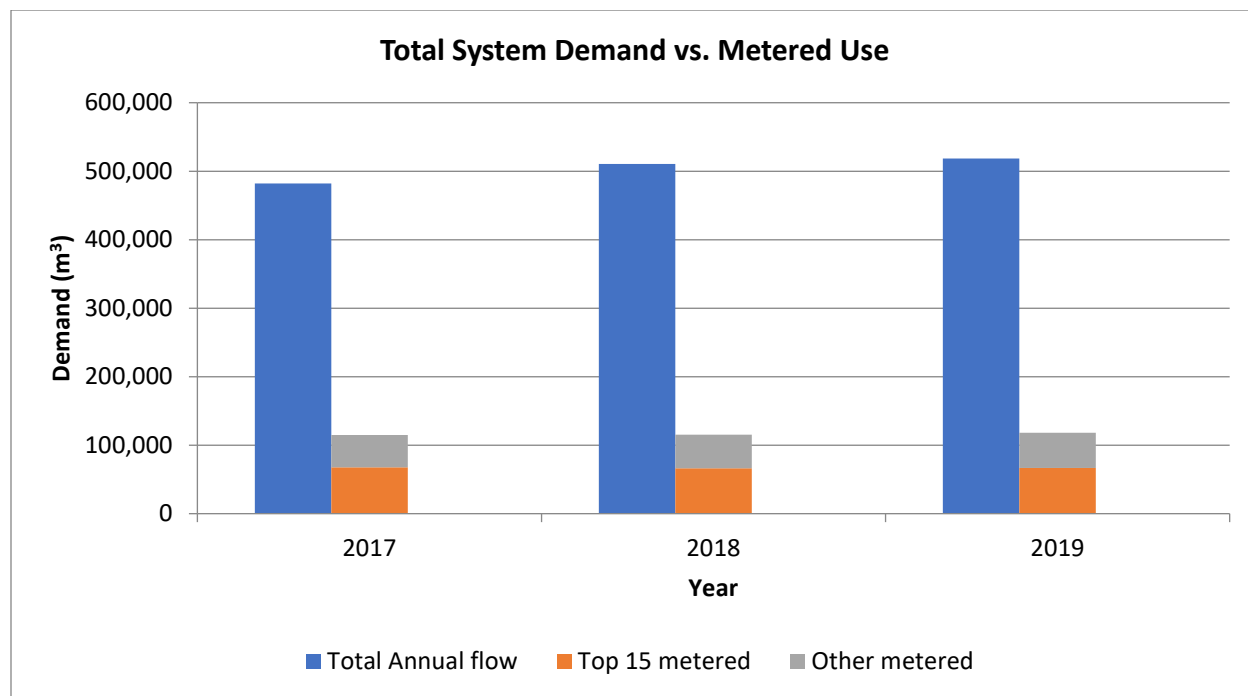
Figure 4.2
Metered Water Use (2017-2019)

The metered water use has generally been consistent during the past three years and there are no noticeable trends. It is therefore considered appropriate to assume the ICI sector water demand will increase at the same pace as residential water demands. Therefore, for purposes of this study, projected overall system water use demands are based on the 275Lpcd value. **Should wet industries arise, this assumption and water system requirements should be revisited.**

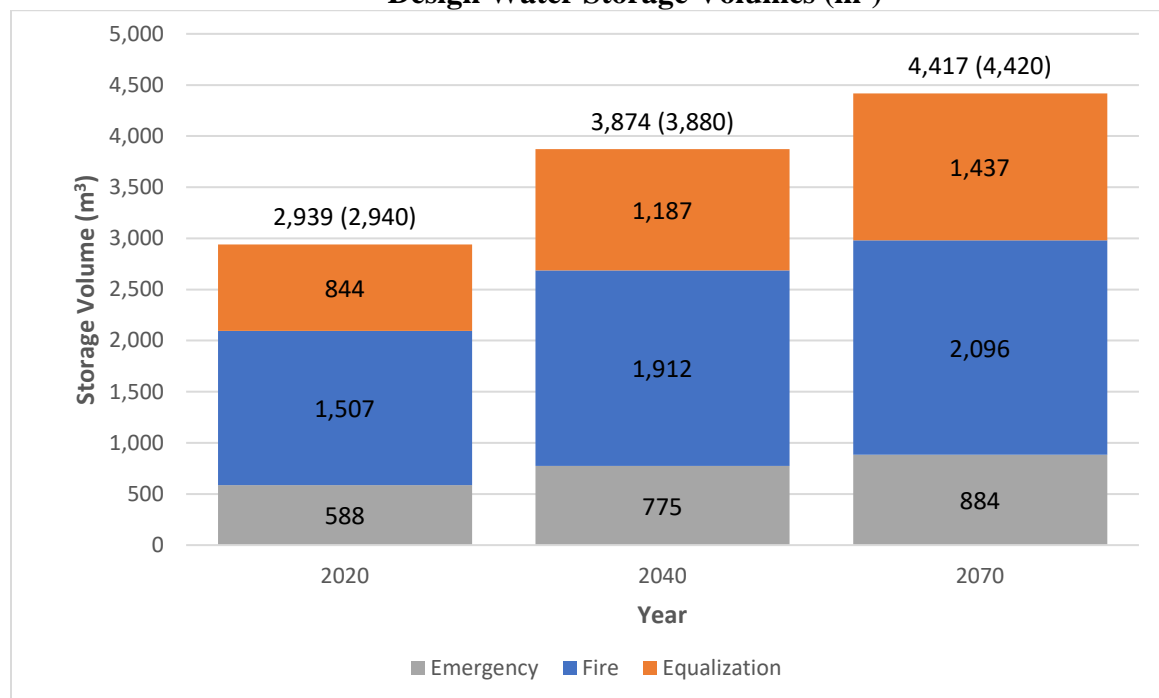
Figure 4.4
Design Water Storage Volumes (m³)

Therefore, the minimum 50-year design water storage capacity is 4,420 m³. The current effective storage capacity of the 35-year-old standpipe (Yr. 1985) is 2,000m³, based on the use of a booster pumping station during higher demand periods such as a fire event. Therefore, if constructing a second storage facility, a minimum additional 2,420m³ is required. Alternatively, if the existing standpipe is demolished and replaced, a single new storage facility could be constructed with a minimum capacity of 4,420m³.

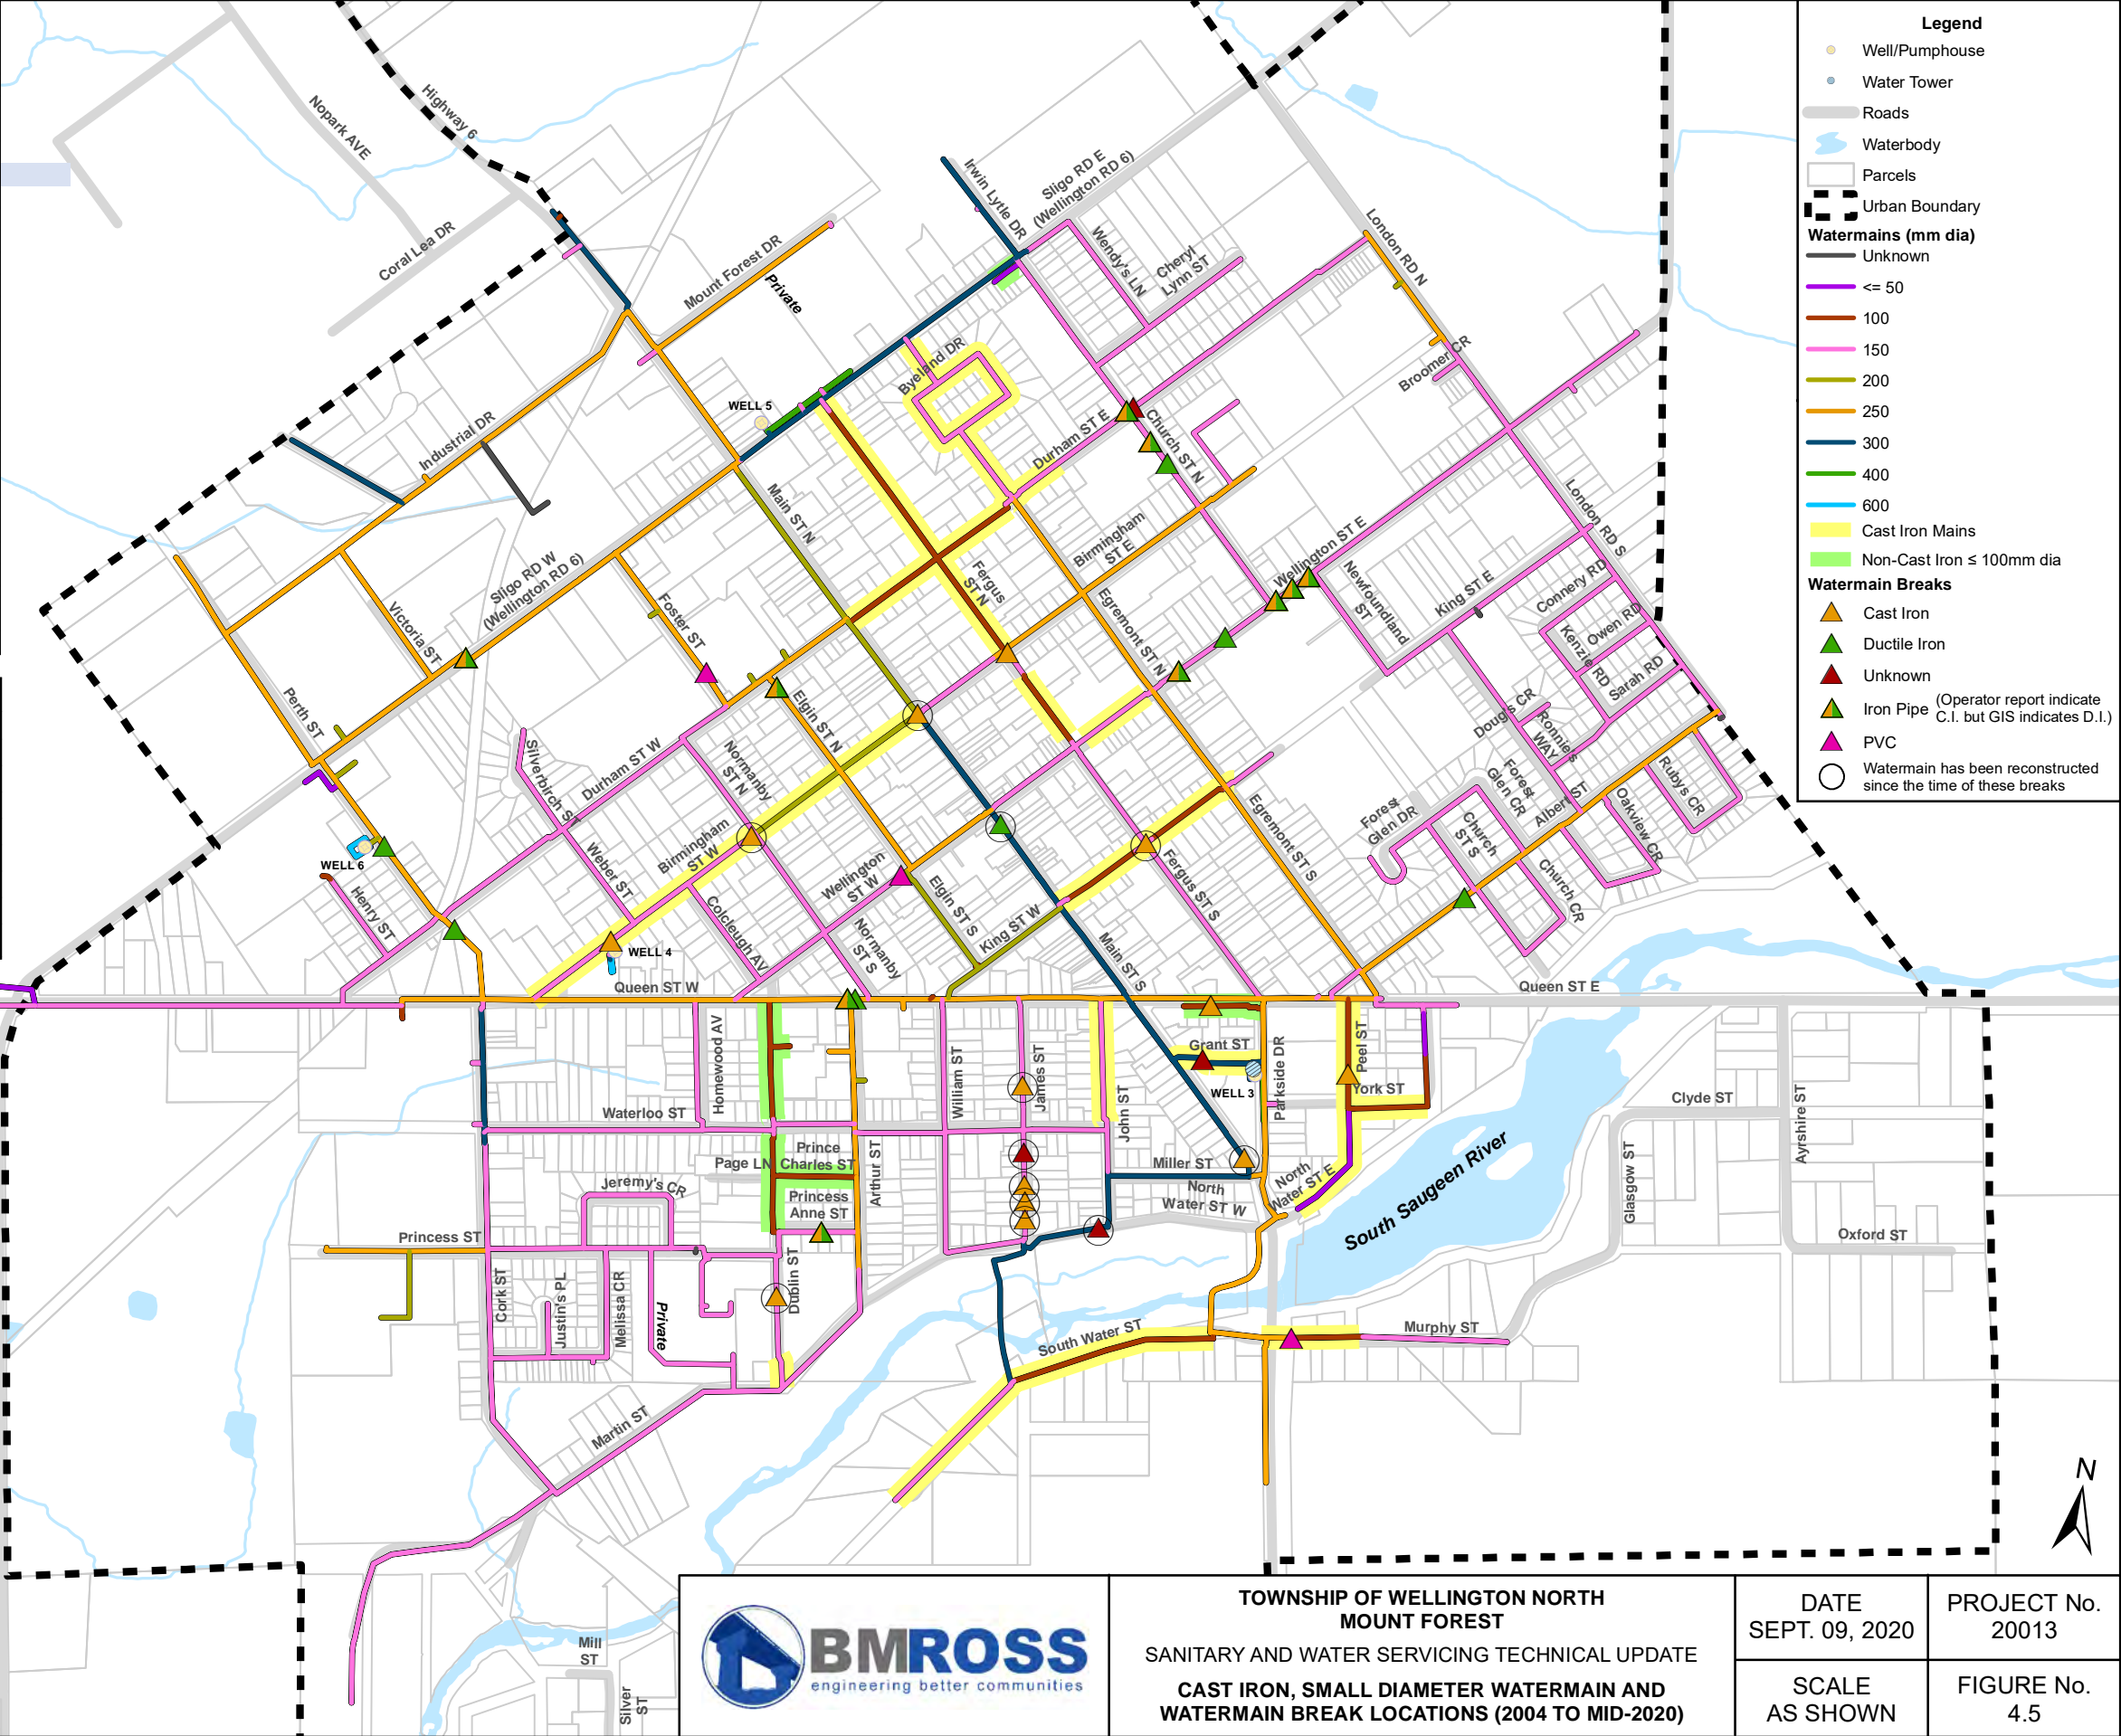
NOTES:
This is a schematic representation of the water distribution system (and roadways). While this drawing and its detail views are shown to a scale, symbols, roadway widths, and watermains are not plotted to scale. Exact locations of many works are not known (based on old non-GPS data). This mapping should be used for general information purposes only.

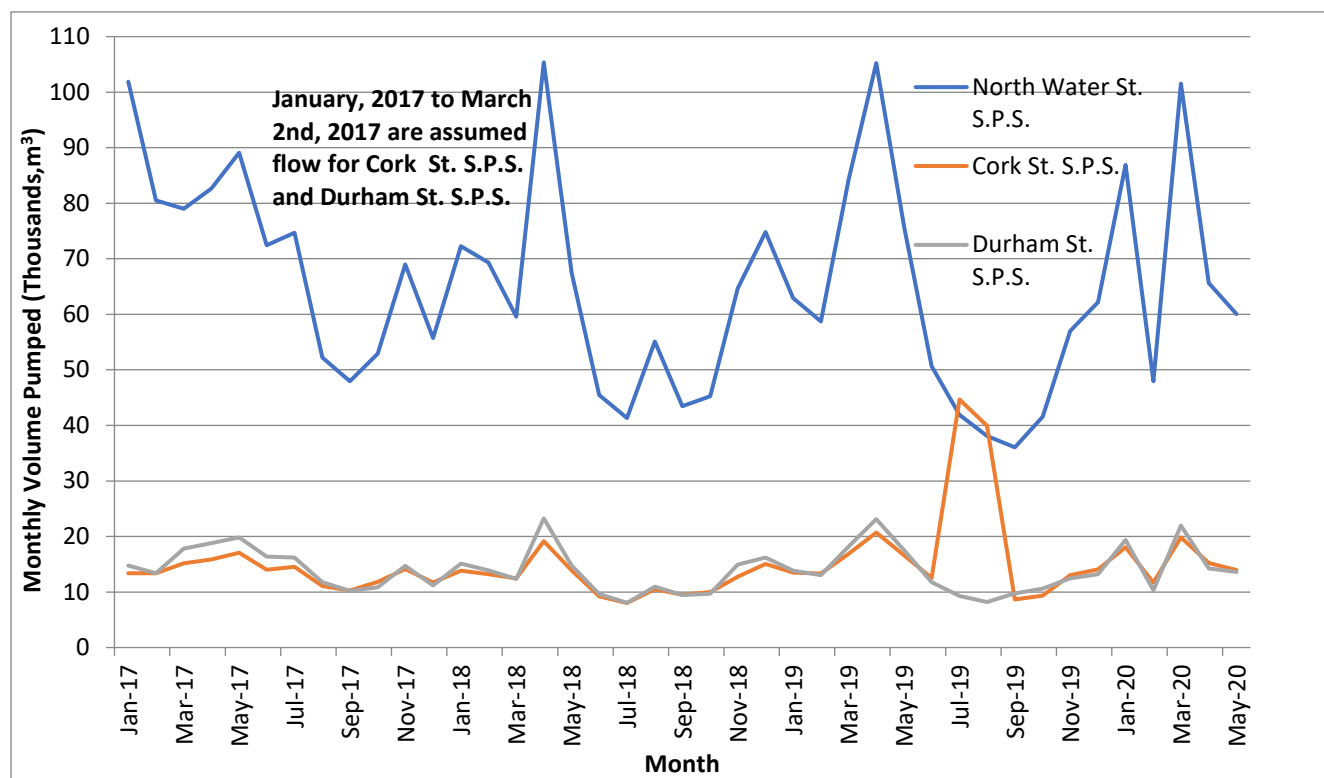
Figure 5.2
Sewage Pumping Station Monthly Flow

Note: It is evident the July and August 2019, Cork Street SPS data is suspect and should be ignored

The 3-year average per capita flow is calculated to be 437 Lpcd. Therefore, the historic use of an average 450 Lpcd sewage flow rate appears to be appropriate in terms of annual average sewage flow to the WWTP. However, the design of the collection system (sewers and pumping stations) needs to consider peak instantaneous sewage flows, to avoid sewer backups into buildings and, as much as possible, raw sewage spills to the natural environment. All major SPS facilities are equipped with overflows.

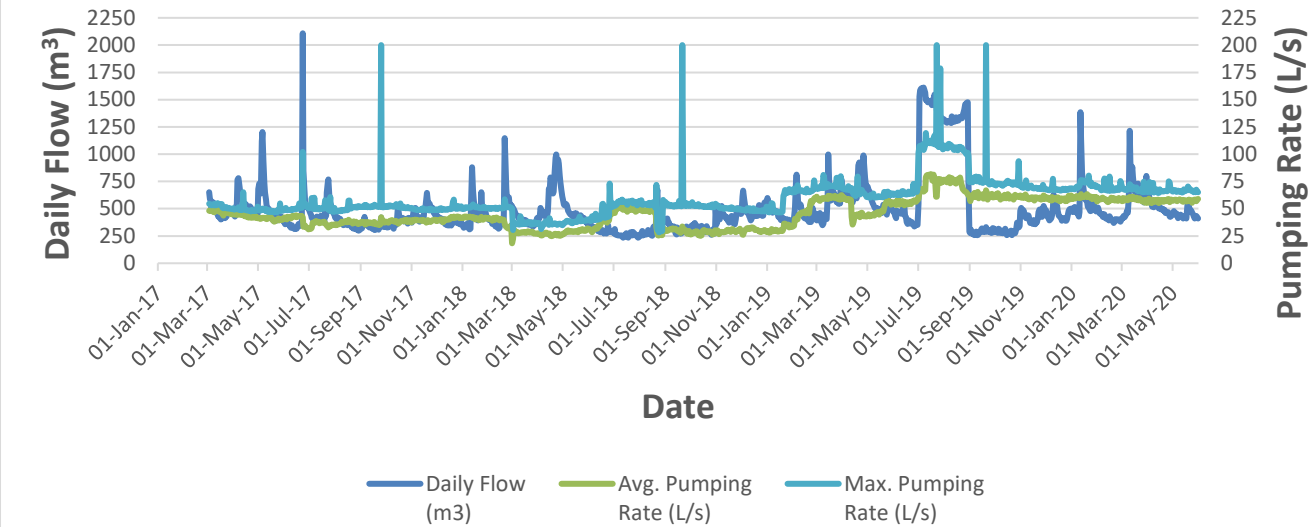
Figure 5.3
Cork Street SPS
Daily Flow and Pumping Rates

1. Cork St SPS: probable recirculation of sewage in mid-2019 as evident by high sustained average daily flows? Mode of pump operation may have changed during some periods as evidenced by higher average daily pumping rates. A number of single random 200L/s maximum pumping rates that are suspect.
2. Durham St SPS: apparent change in mode of pump operation beginning in late-2019, as evidenced by higher average day and maximum day pumping rates. A few random occasions of 160-180L/s maximum pumping rates that are suspect.
3. North Water St SPS: A see-saw pattern of maximum daily pumping rates began in mid-2018 and continued up until October 2019. In addition, beginning in early-May, 2018, there was a drop in the average daily pumping rate and daily flow recordings. These changes were not investigated as part of this study. It may be meter calibration or the mode of pumping was altered.

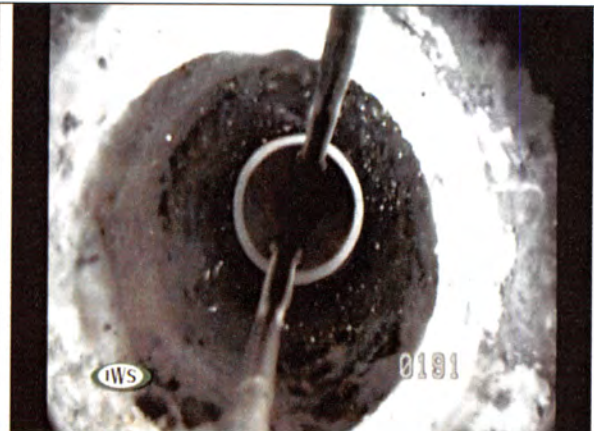
Casing condition at 57 feet

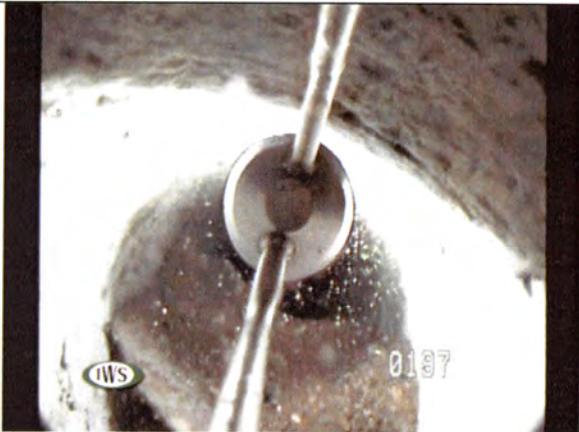
Bottom of casing at 191 feet

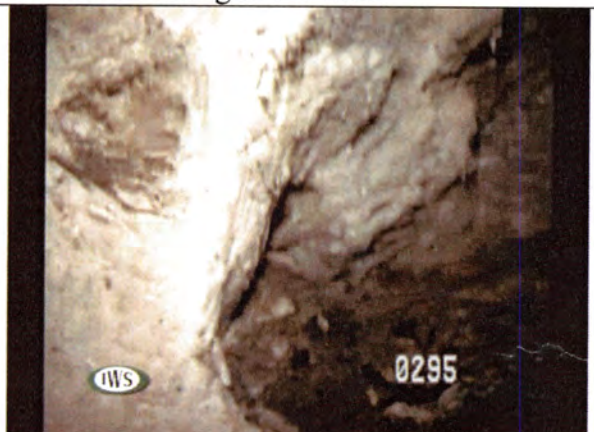
Vertical view of refusal at 197 feet

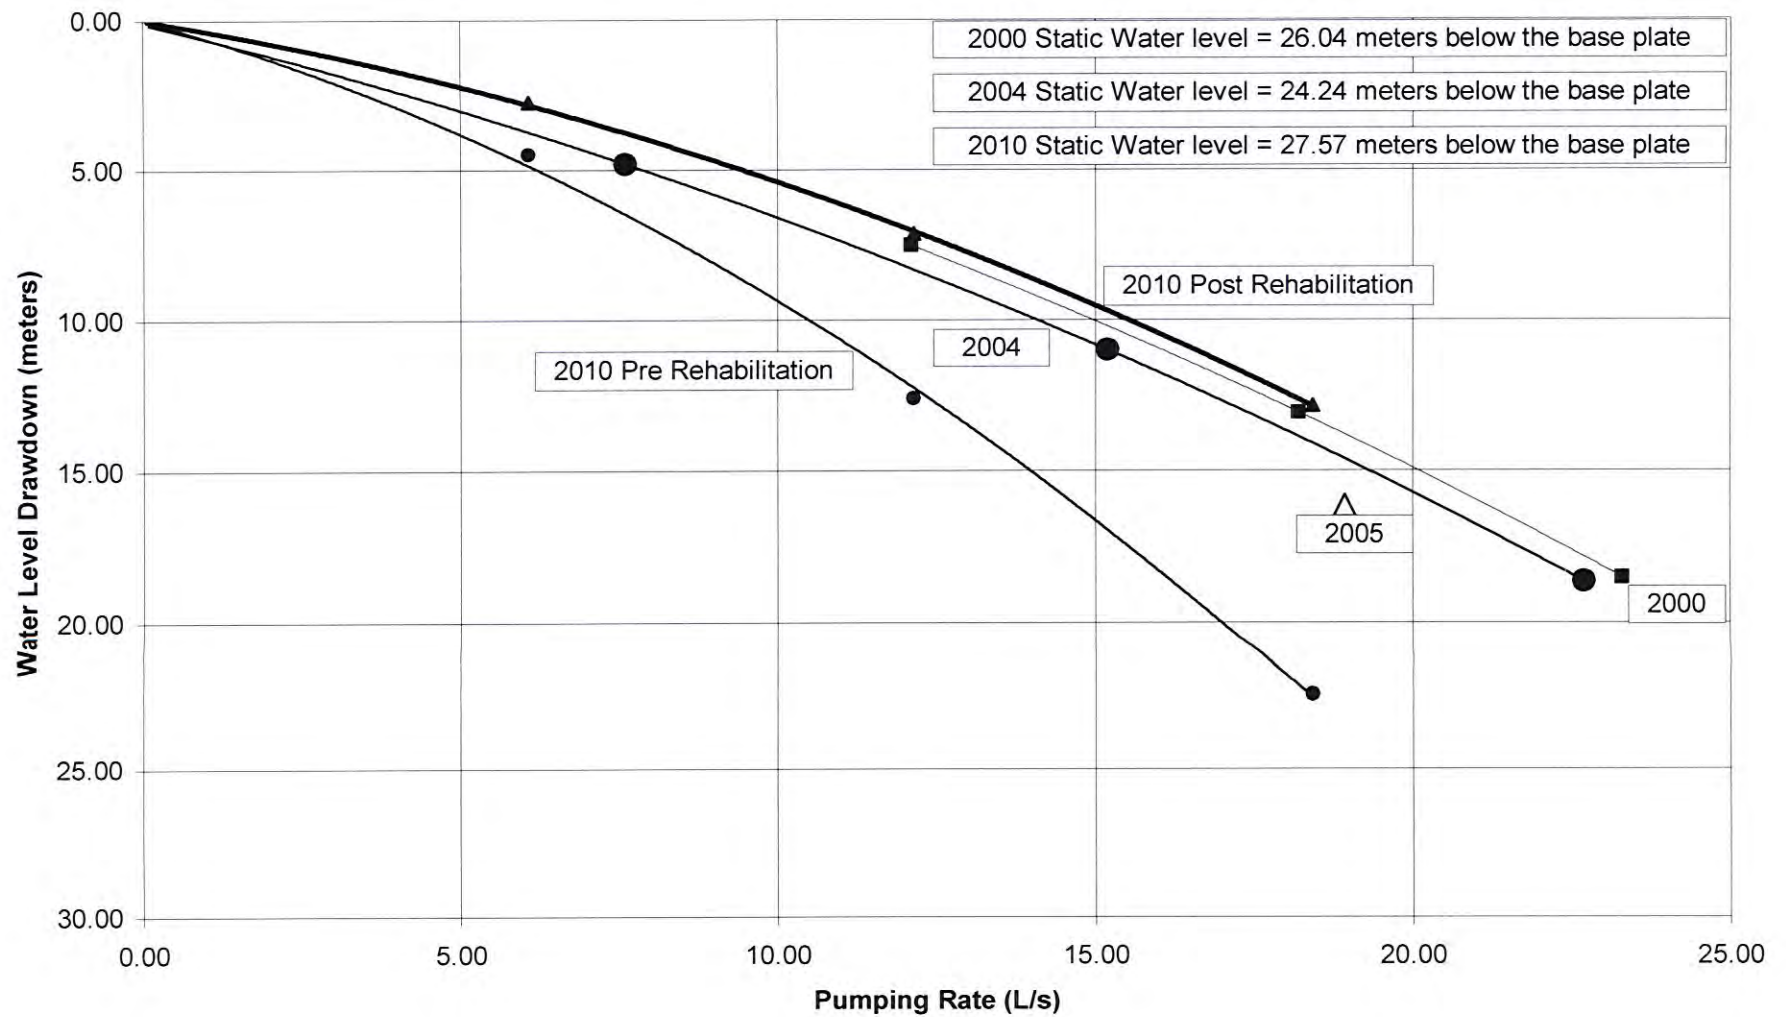
Figure 1: Pumping Rate versus Drawdown
Mount Forest Well 3: Variable Rate Step Test - 2010

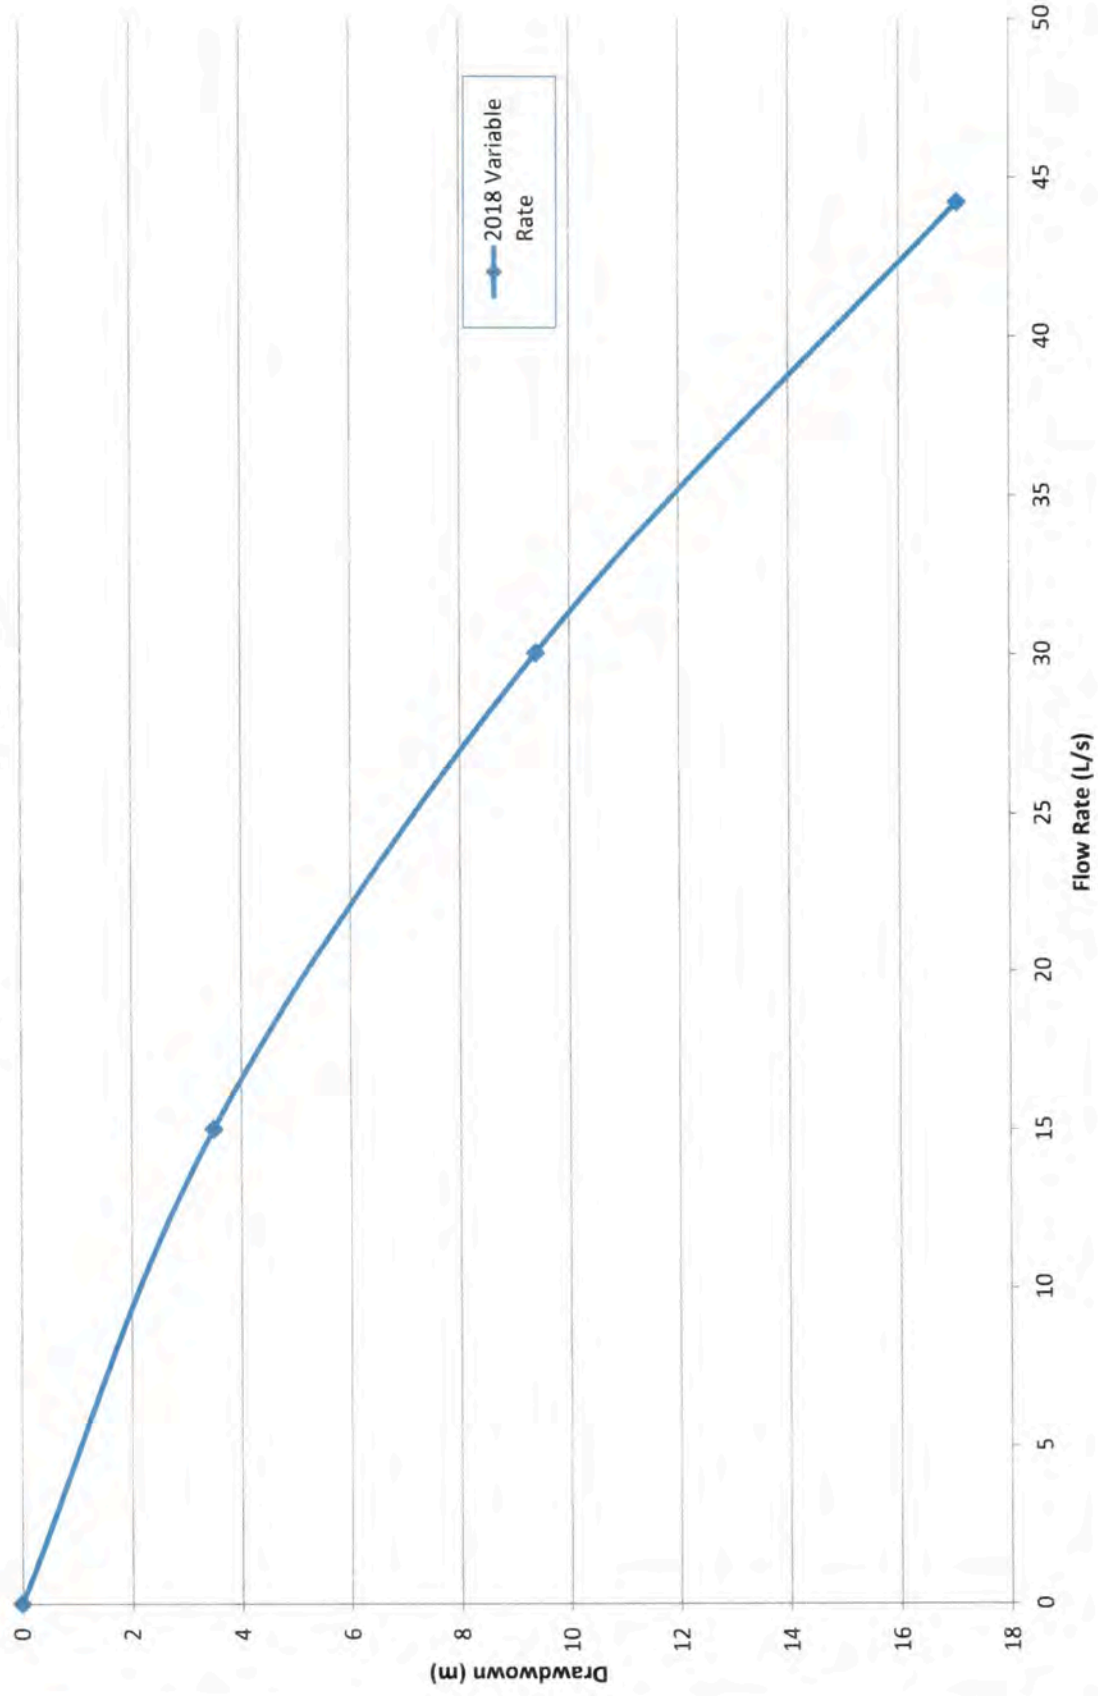
**Figure 1: Drawdown Chart
Mount Forest Well #5**

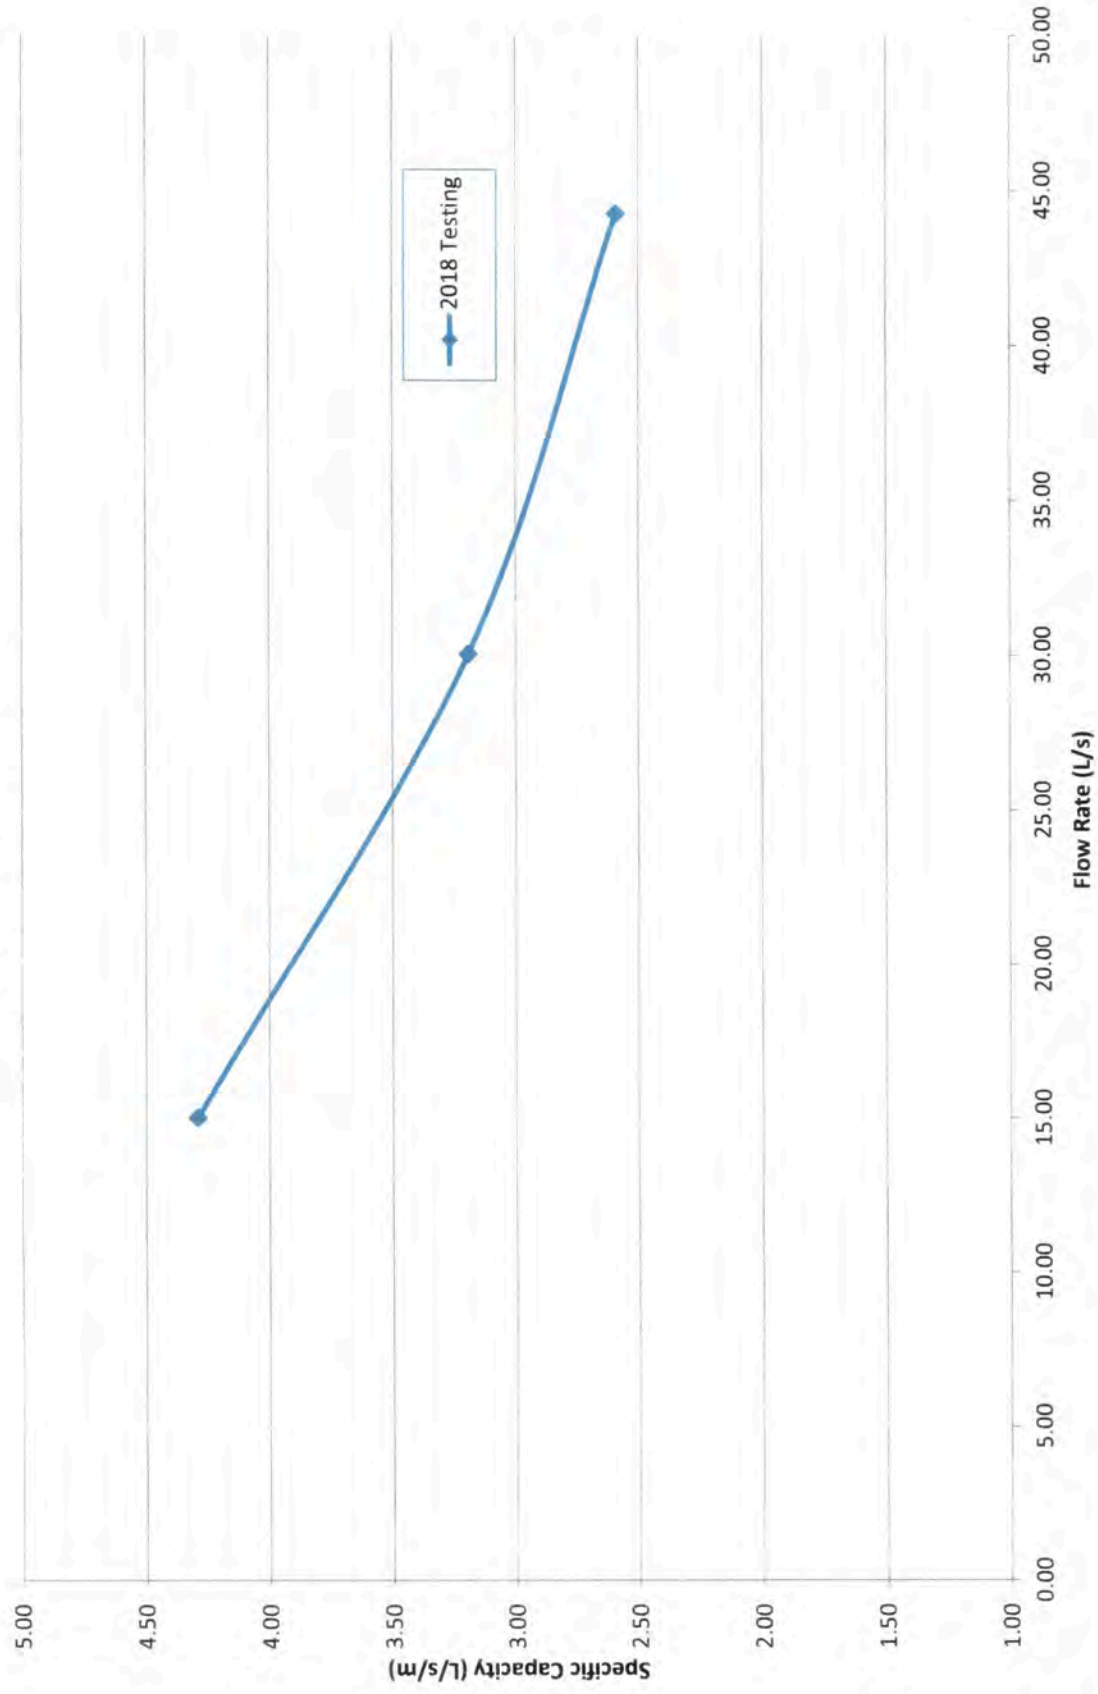
**Figure 2: Specific Capacity
Mount Forest #5**
