**MOUNT FOREST
SANITARY AND WATER SERVICING**

TECHNICAL UPDATE

January 6, 2021

File No. 20013

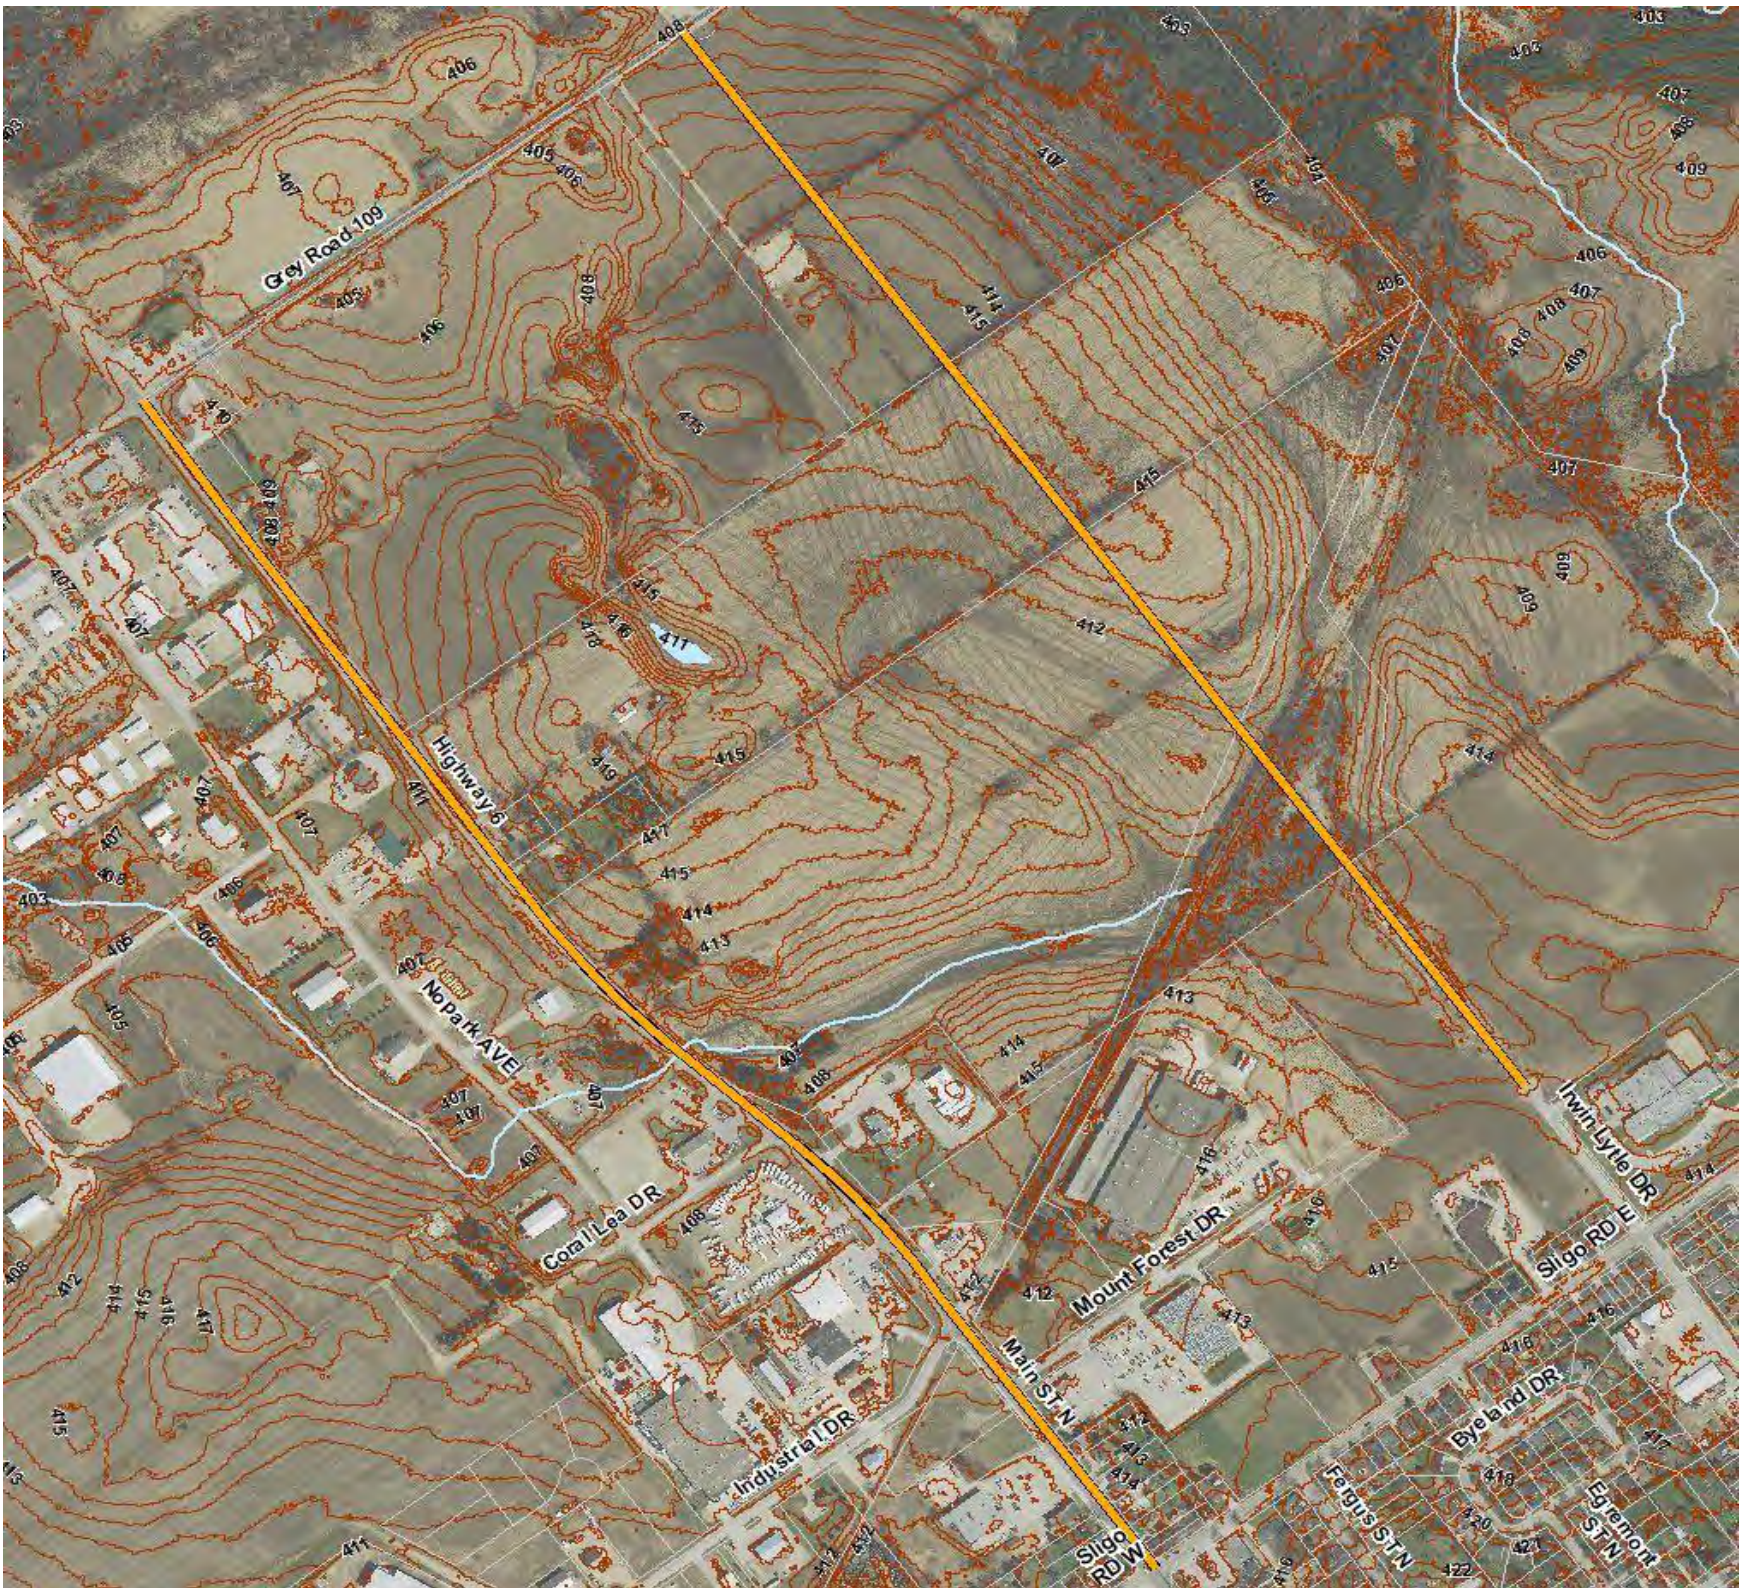
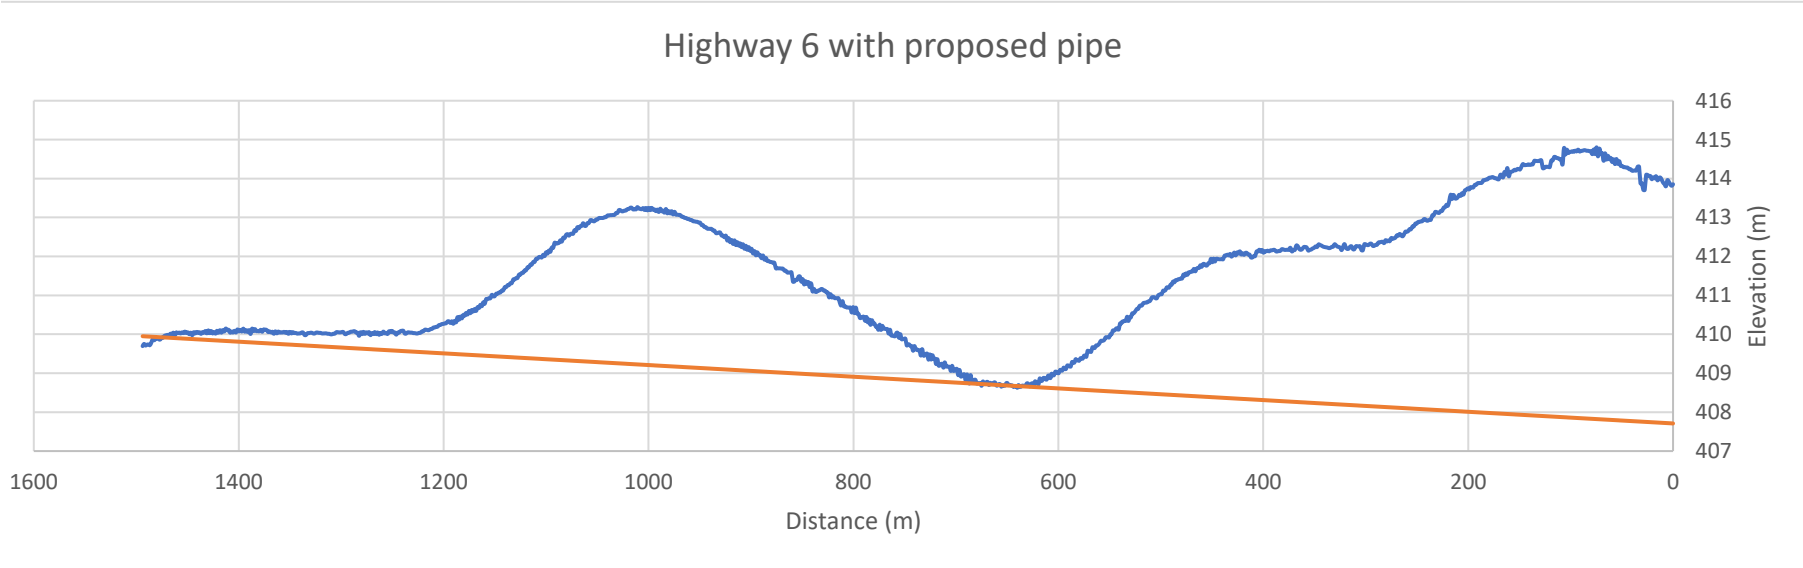
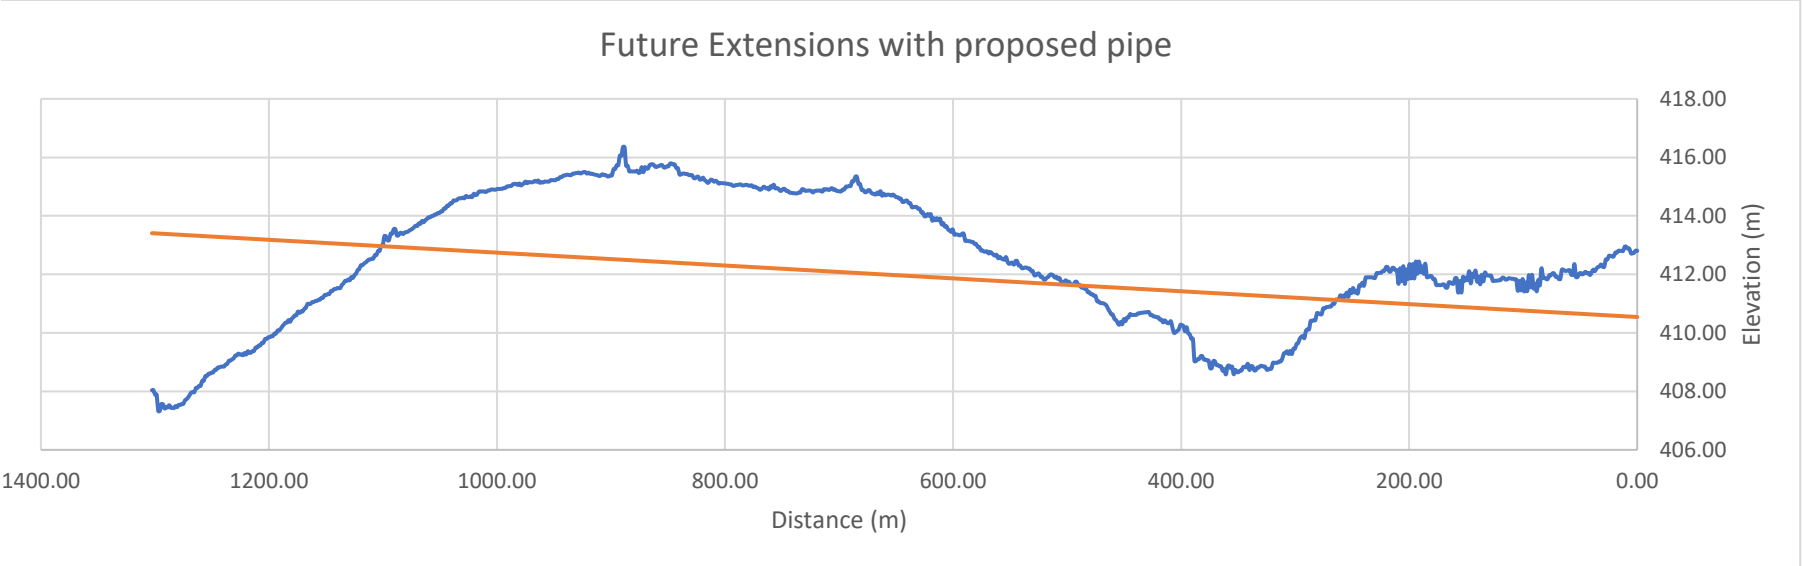
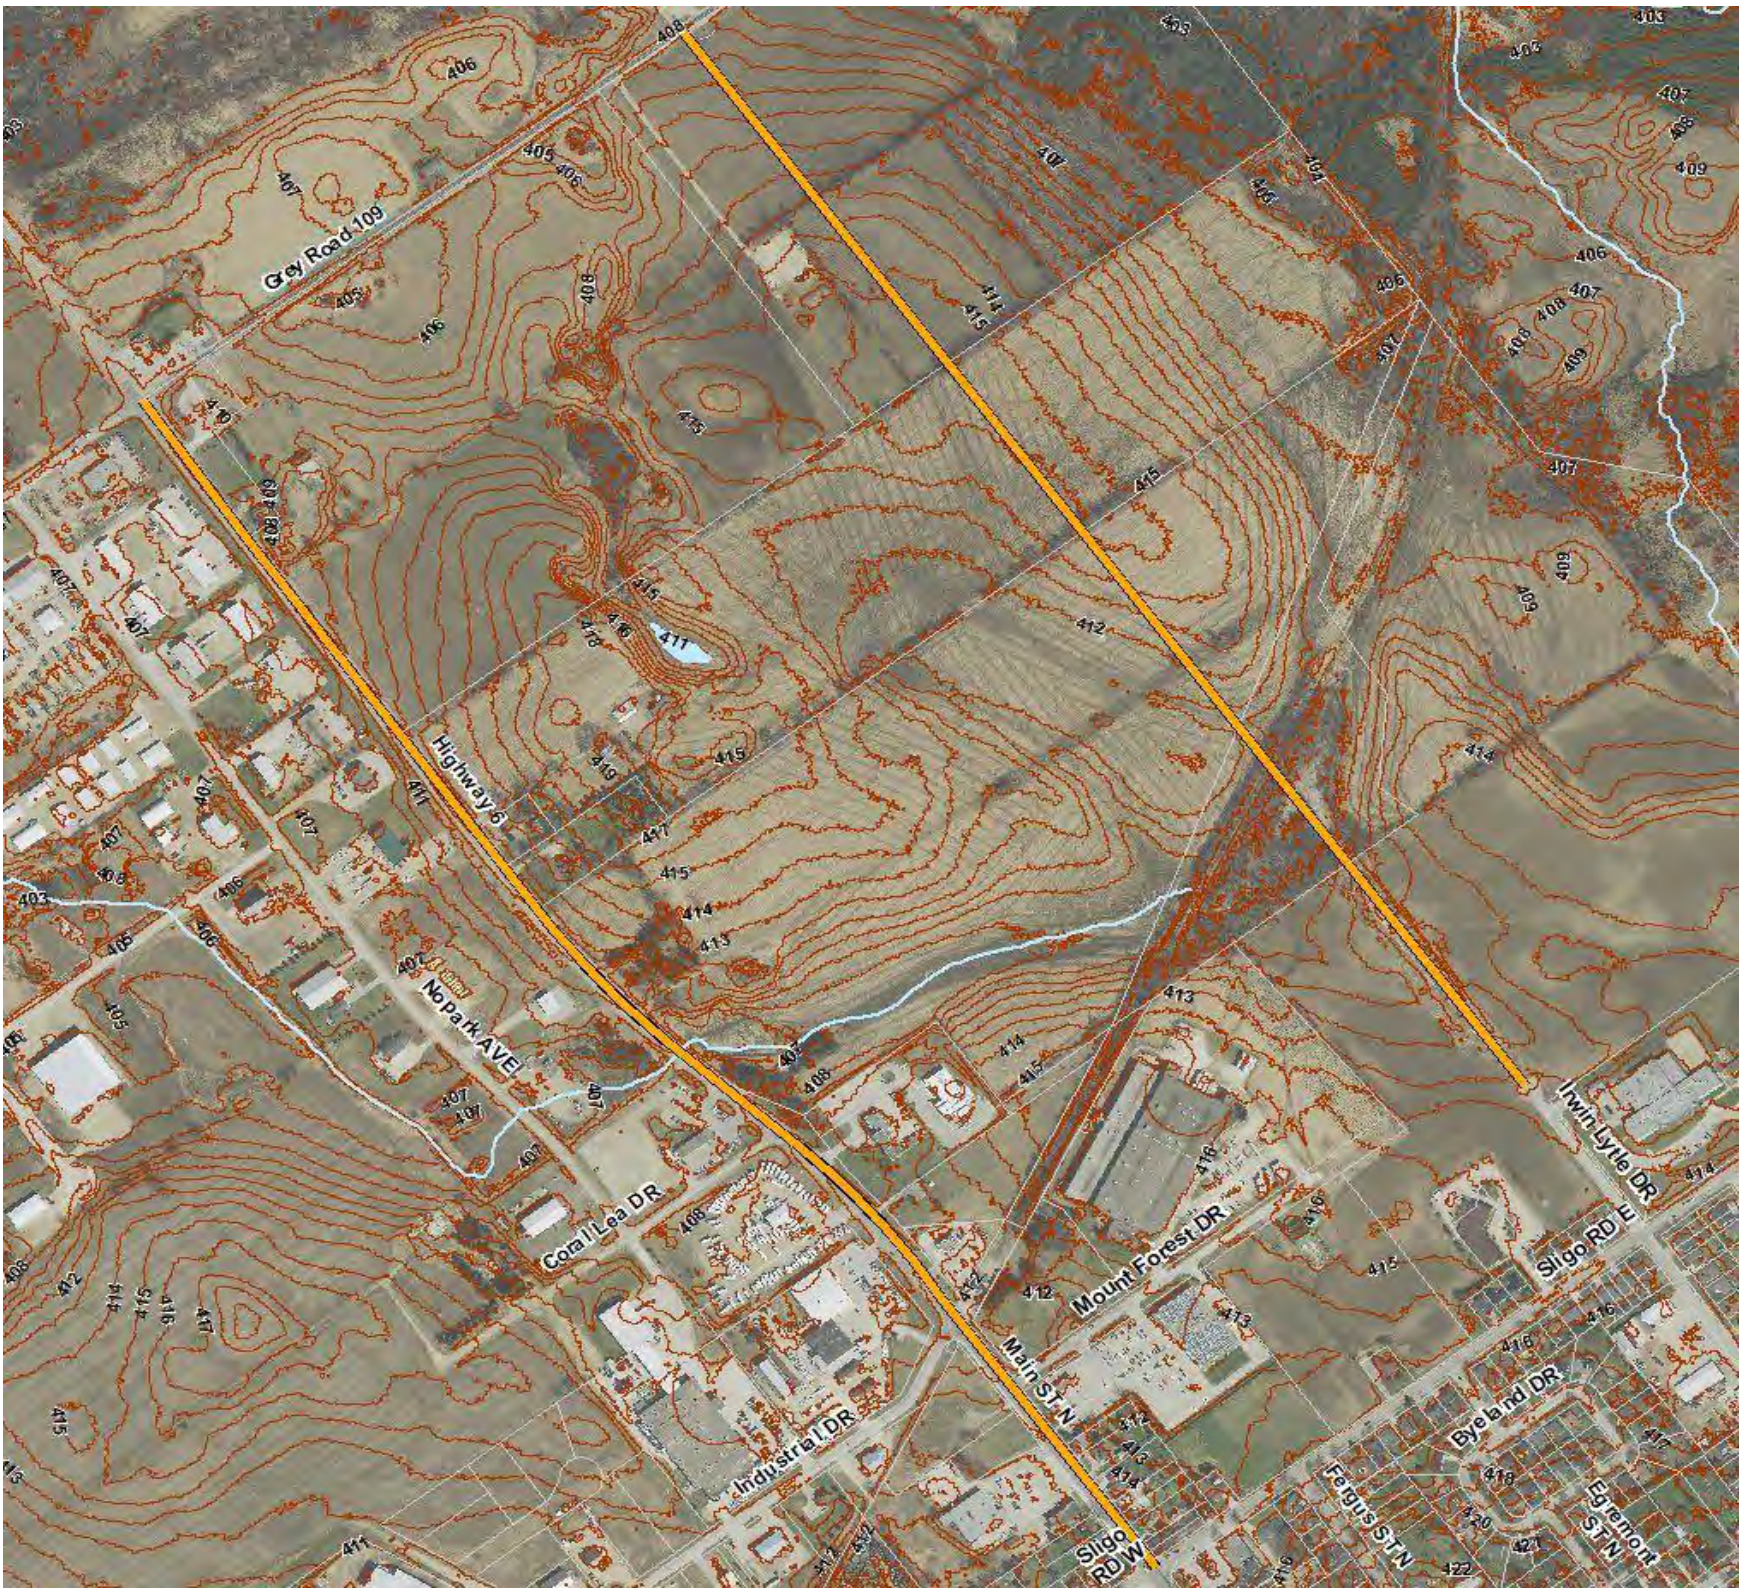
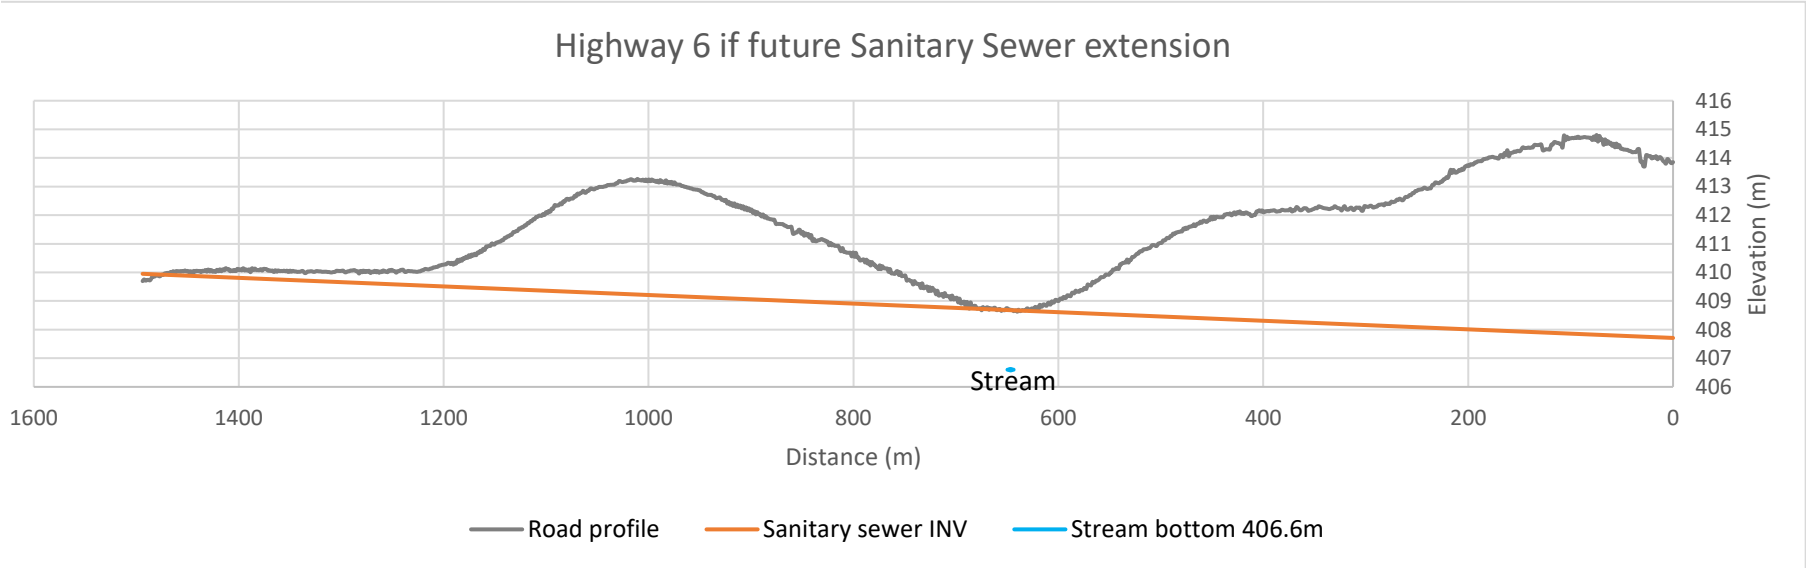
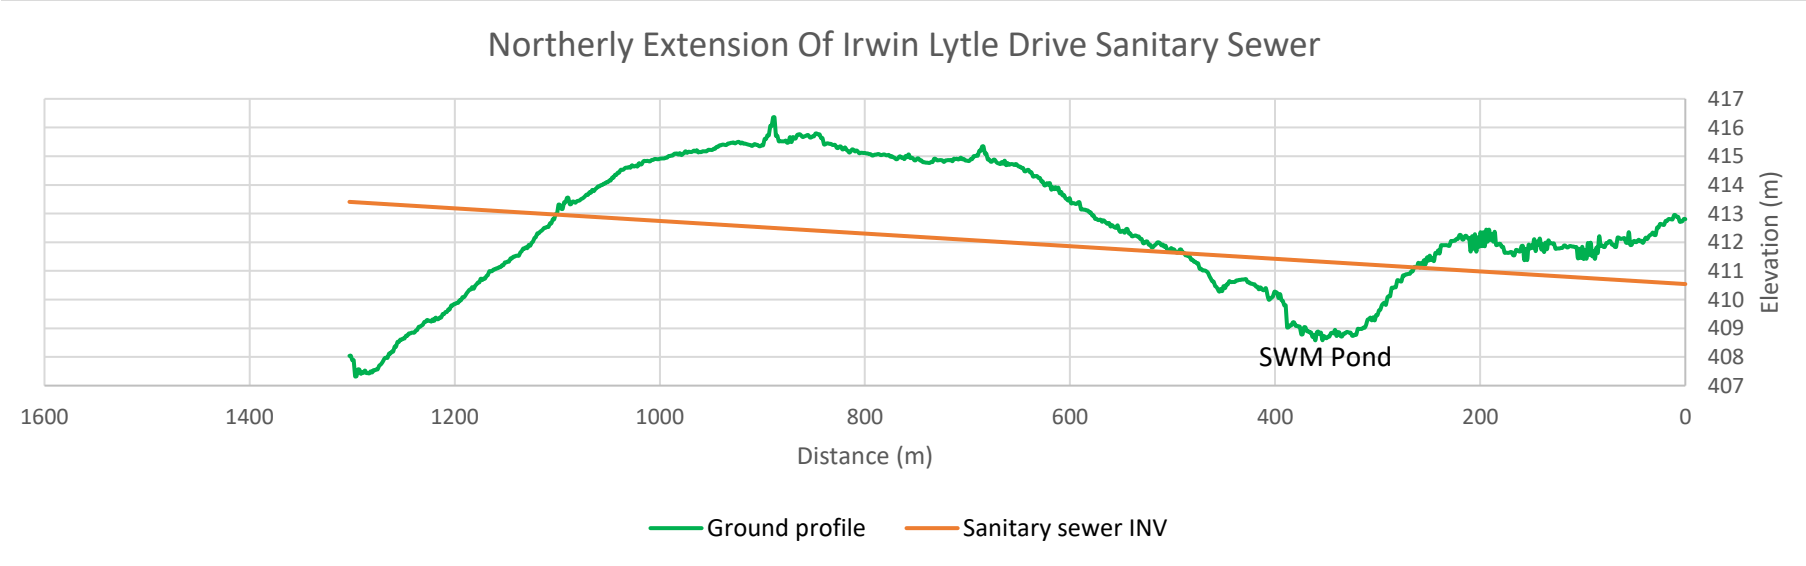
APPENDIX H
CONCEPTUAL SANITARY SEWER
EXTENSION PROFILES

The above two figures indicates gravity sewer servicing for the future serviced Industrial Area within the former Egremont Annexation will not be feasible. A Sewage Pumping Station is required for sanitary servicing, due to stream crossing.

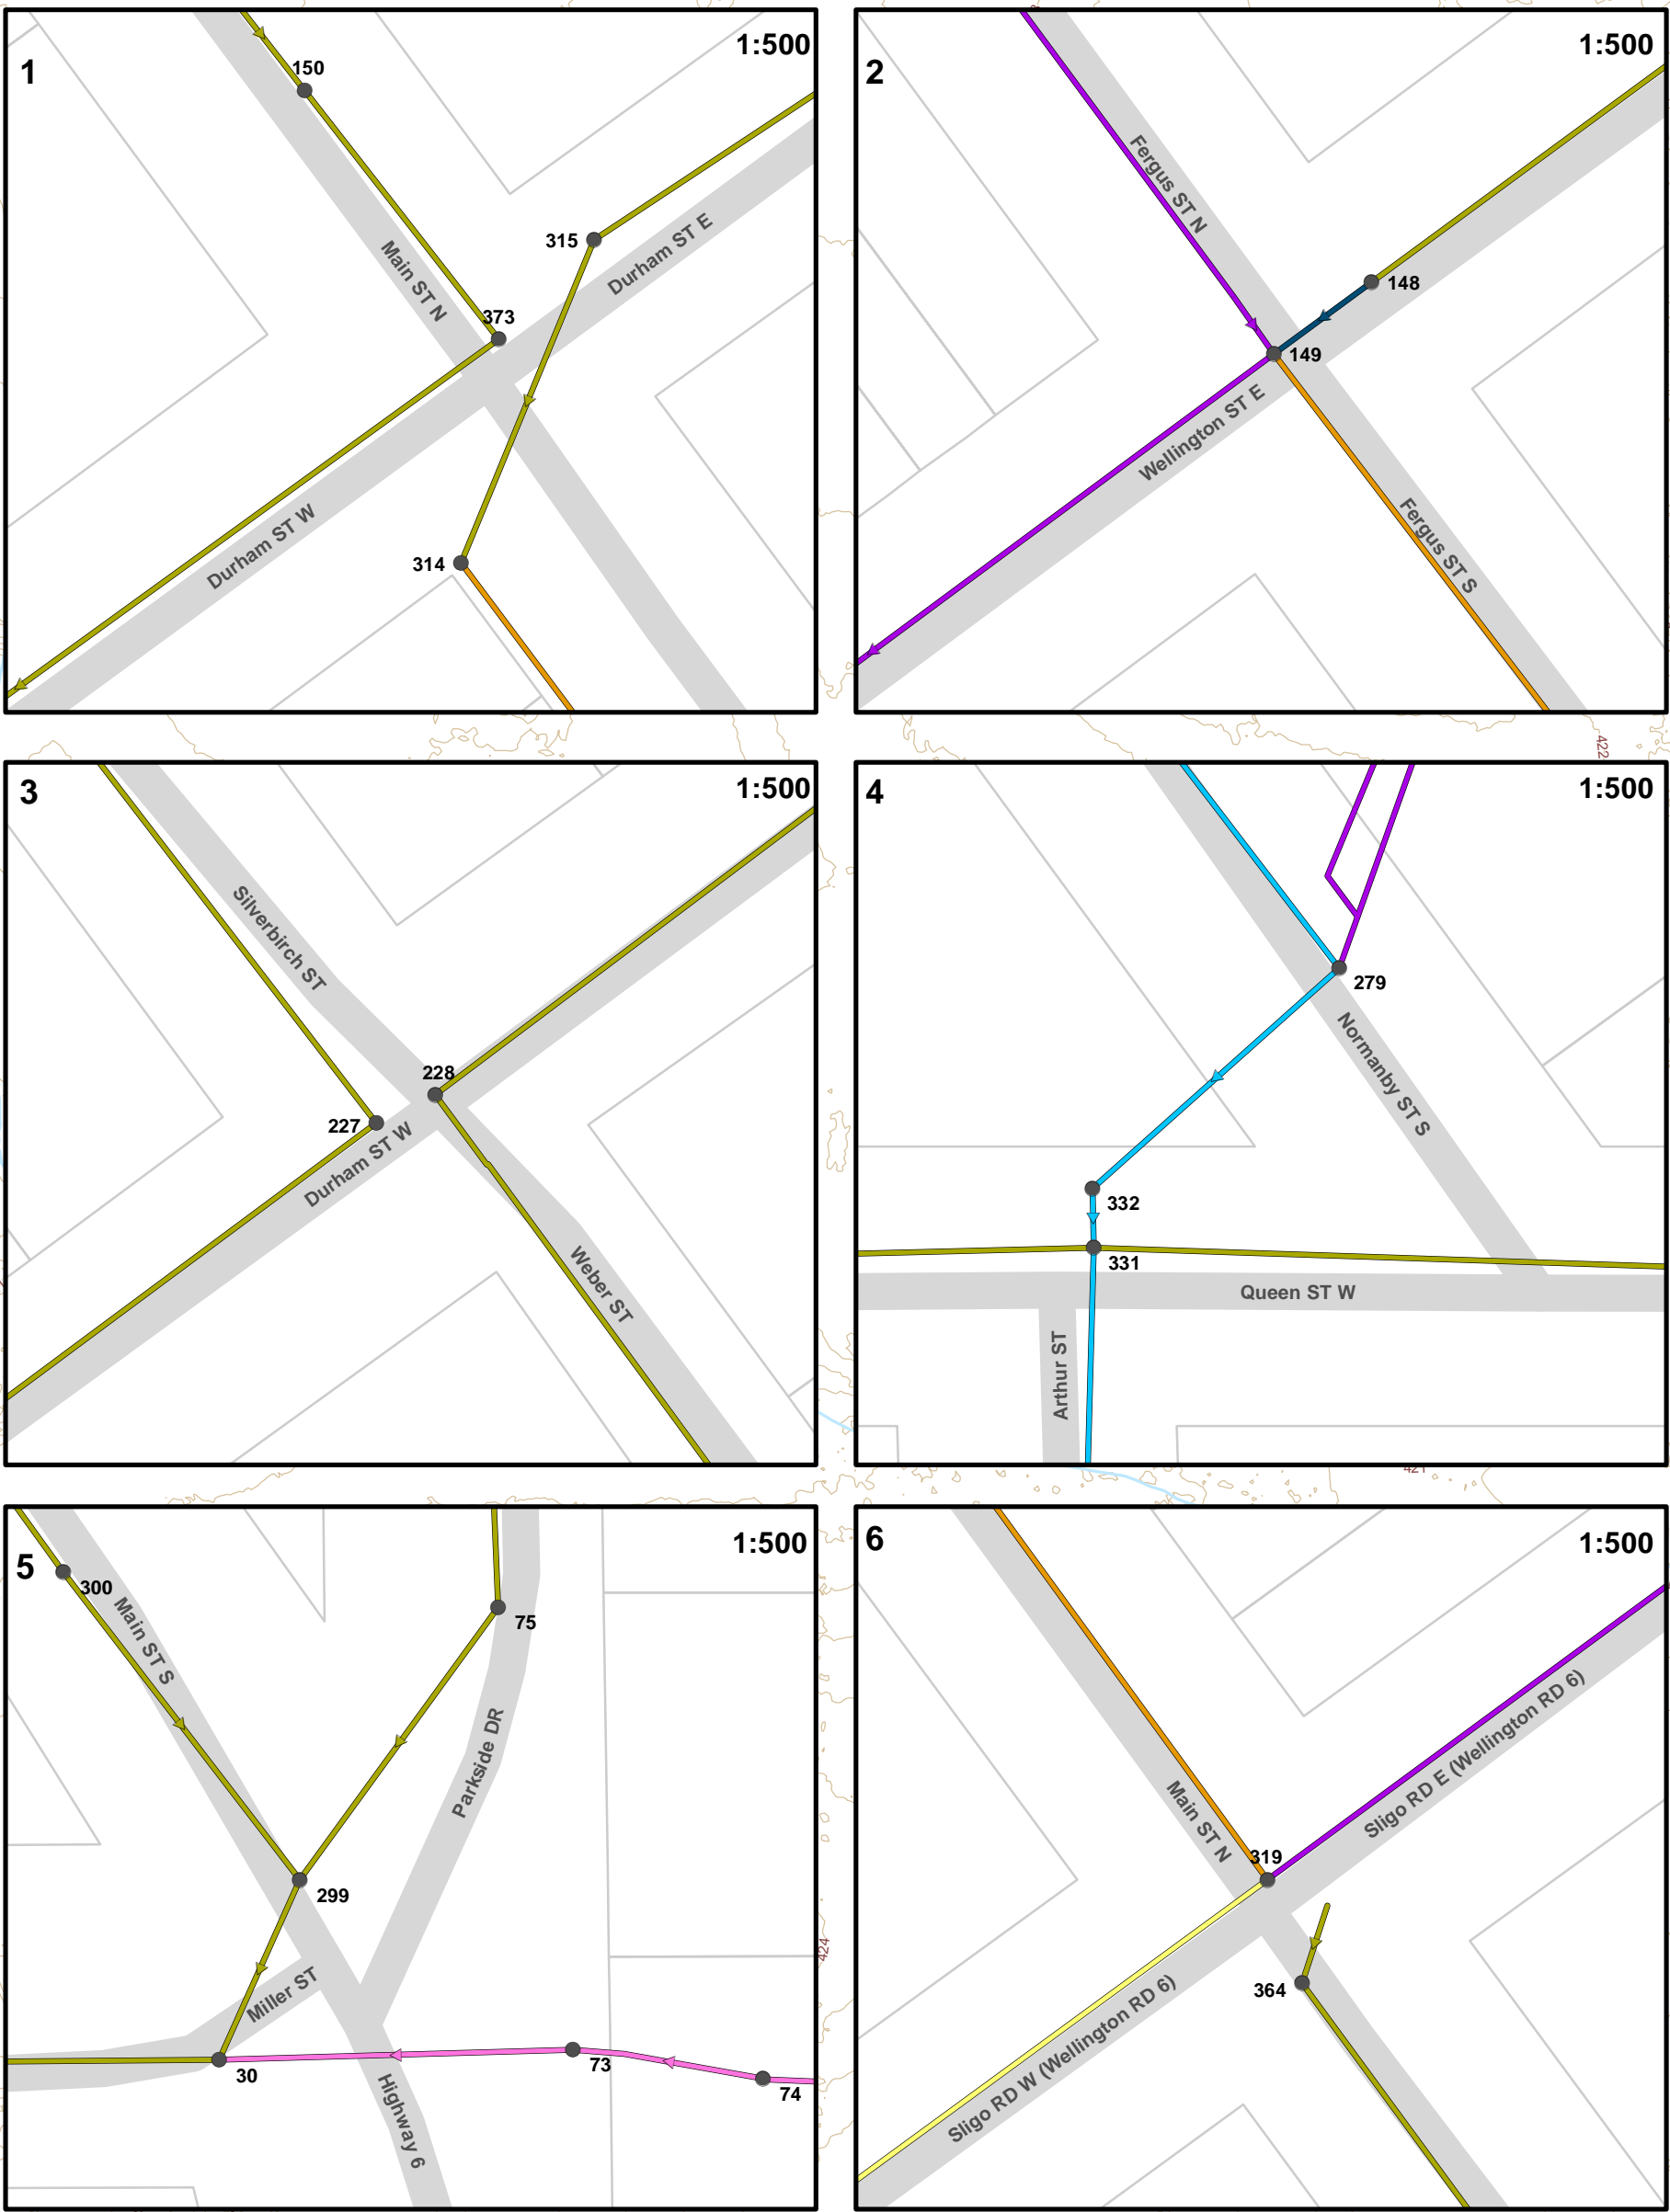
NOTES:
This is a schematic representation of the sanitary system (and roadways). While this drawing and its detail views are shown to a scale, symbols, roadway widths, and sanitary lines are not plotted to scale. Exact locations of many works are not known (based on old non-GPS data). This mapping should be used for general information purposes only.
